NI 43-101 Technical Report Mineral Resource Estimate for the Santana Project Sonora State, Mexico

Minera Alamos Inc.

Effective Date: May 31, 2023

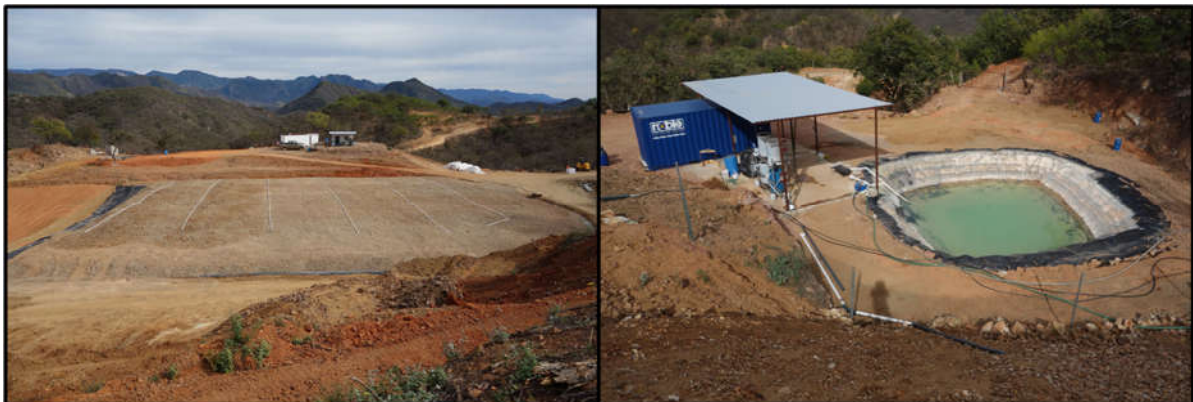
Figure 4-3: Bulk Heap Leach Pad and Test Plant

Source: Photo 1 (left)—Minera Alamos Inc., April 13 2018, Looking Southeast, photo taken at the Santana Project pilot leach pad.
Photo 2 (right)—Minera Alamos Inc., April 13 2018, Looking Northeast, photo taken at the Santana Project test plant.

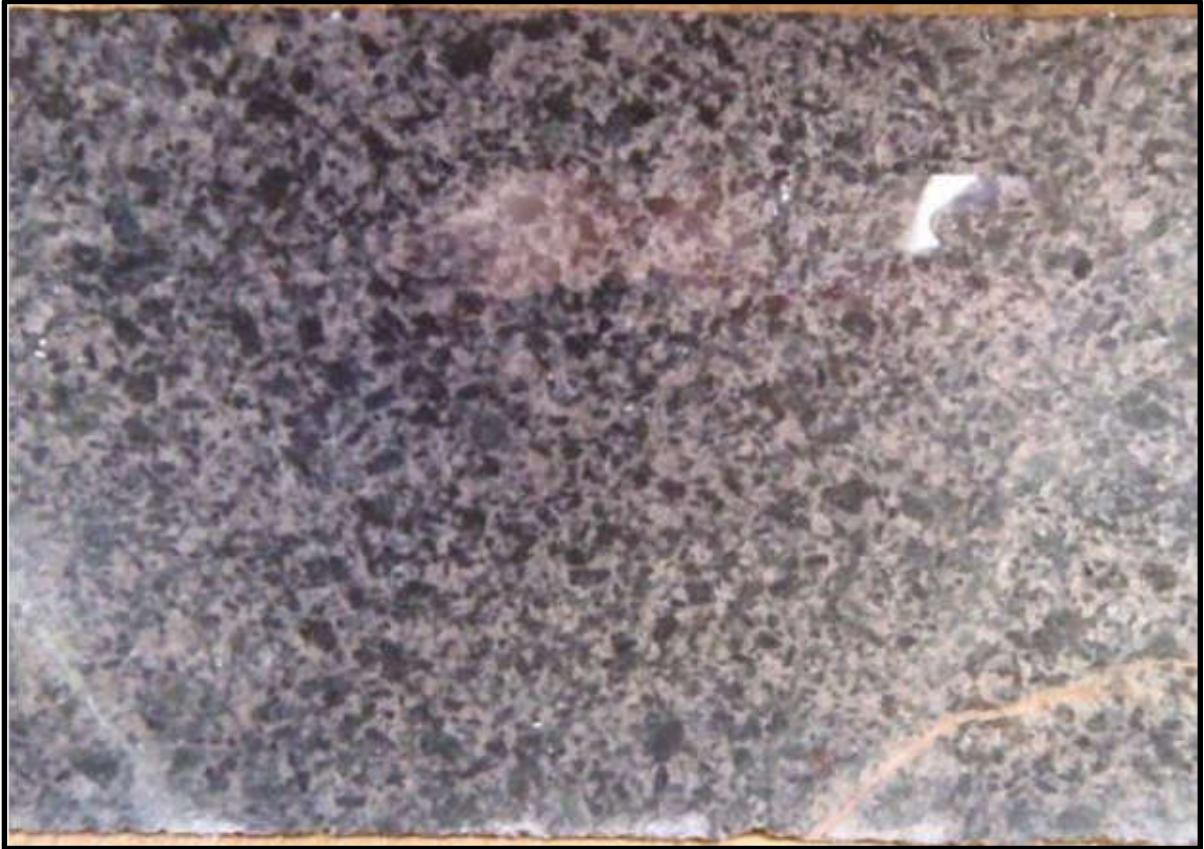
Figure 7-4: Fresh Monzonite (S10-063D). Plagioclase Phenocrysts Are of Dark-Grey Colour with a Reddish Matrix. Hornblende is Partially Altered to Chlorite.

The batholith in the Project area consists of several intrusive units in the form of stocks and dykes of quartz–monzonitic or monzonitic composition, and a more mafic–rich coarser–grained unit that could be a hornblende and biotite monzodiorite or monzonite (Figure 7-4). This latter rock is magnetic, with propylitic overprint marked by pervasive chlorite and epidote (Figure 7-5). Quartz monzonite occurs as stocks in the northeastern area of the Project and as dykes varying from 1 m to 10 m thick in the volcanic units. It can be distinguished by its content of quartz fragments, reddish colour when fresh, and a fine–grained matrix (Figure 7-6).

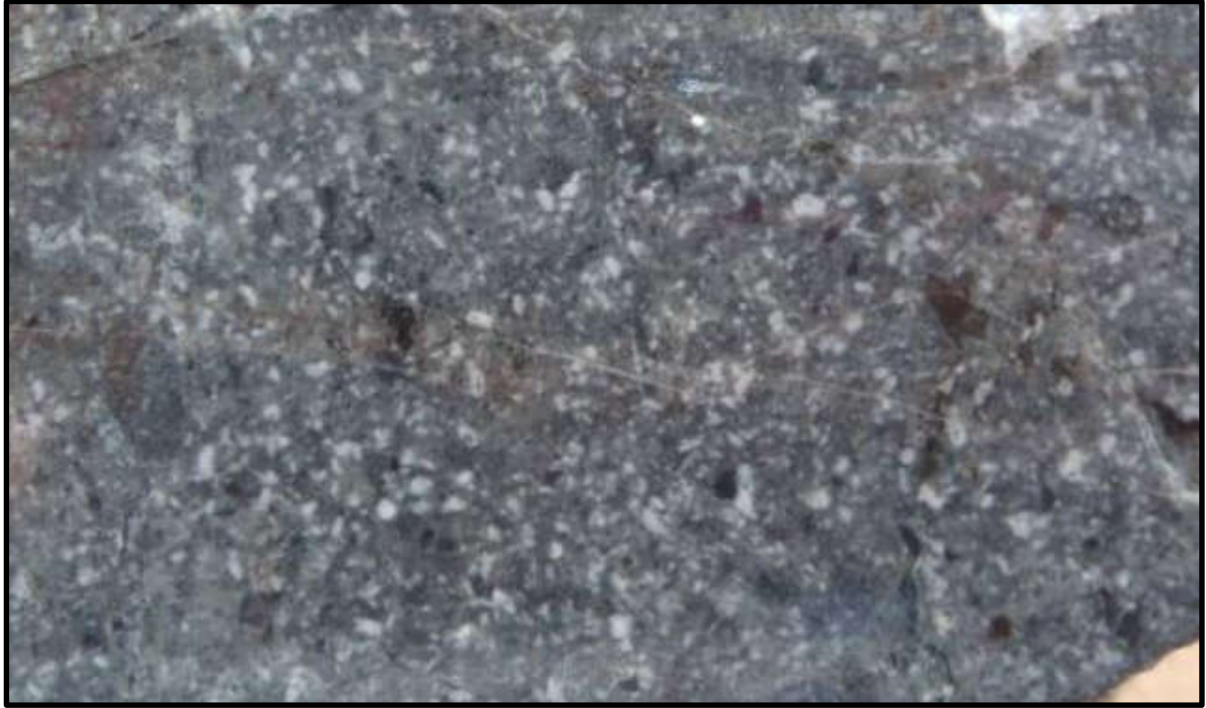
Figure 7-5: Pervasively Chloritized Monzodiorite (S10-43D at 262 m) Original Grey Phenocrysts are Partially Altered to Illite

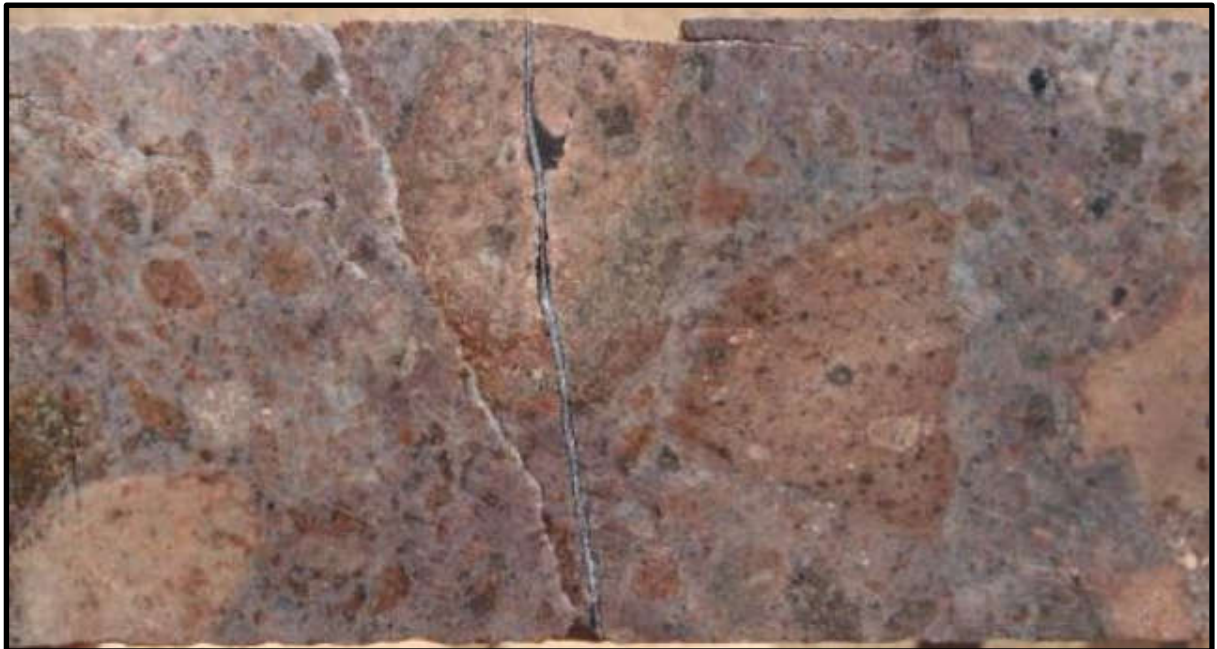
Figure 7-6: Dyke of Quartz-Monzonite (with xenoliths) from Hole S10-43D at 228 m

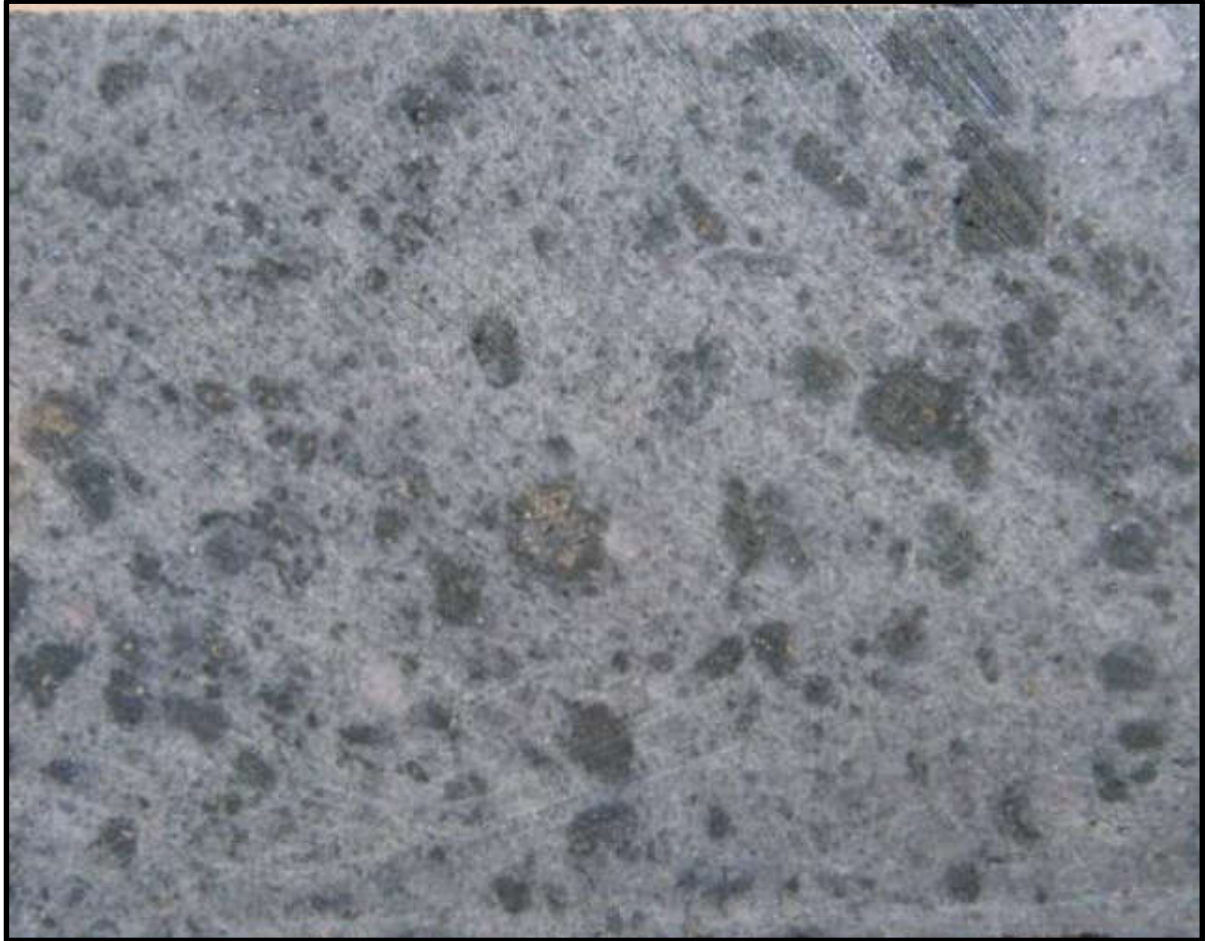
Figure 7-8: Chloritized Andesite with Small Clasts of Volcanic Composition and Lithic Components. Pyrite is Introduced with Chlorite Affecting the Darker-Coloured Clasts.

The Tarahumara volcanic rocks in the Project area consist of an andesitic unit and an underlying felsic-flow unit. Andesites vary from fine-grained to porphyritic (Figure 7-7, Figure 7-8, Figure 7-9). Several units show elevated amounts of lithic and rounded to semi-rounded polymictic fragments, tuffaceous material, and auto brecciated flows (Figure 7-8). The andesitic unit can vary from 100 to several hundreds of metres thick. The underlying felsic unit can be distinguished by its flow texture, lighter colour, quartz crystals, and hardness. Despite being heavily silicified in large part (associated to tourmaline), its groundmass is more silica-rich and appears to be dacitic or rhyolitic in composition, as seen in small sections of fresh rock. Identifying this is often more difficult when it is more intensely altered because it changes from a dark grey porphyritic rock (with white feldspar phenocrysts of 2 mm–3 mm) to a whitish rock with strong flow-banding that is highlighted by a sericitic alteration (Figure 7-10, Figure 7-11, Figure 7-12 Vale 12, 13, 14).

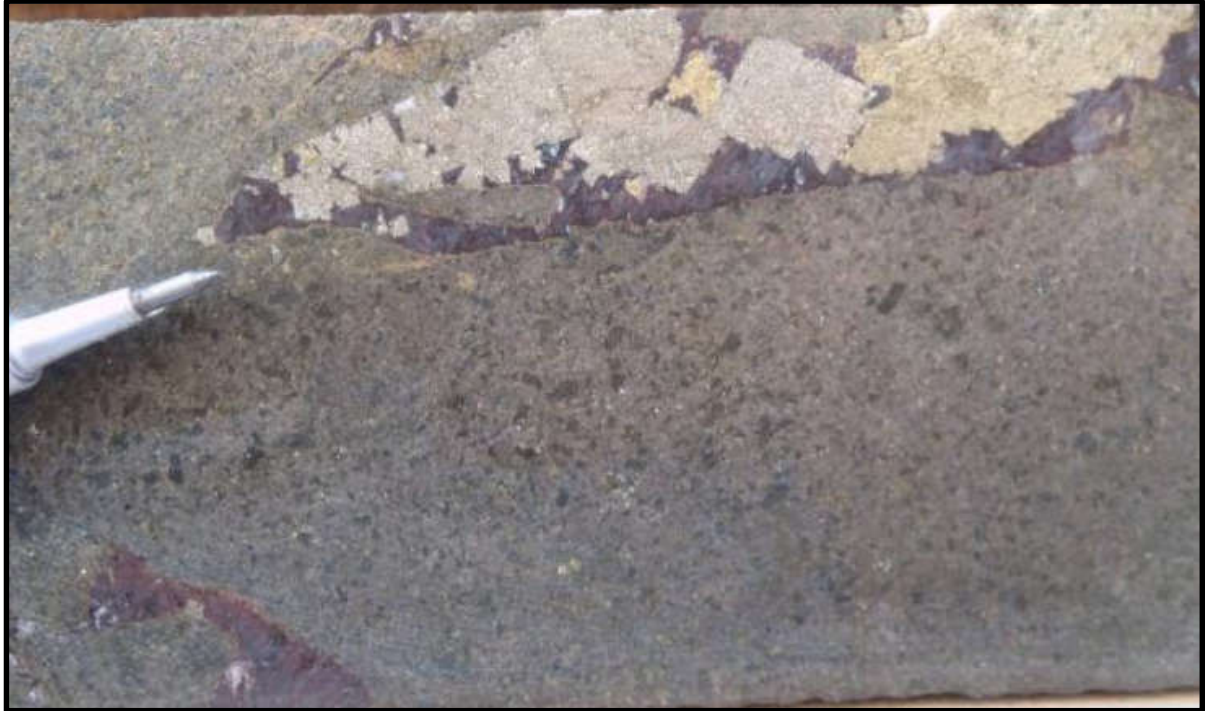
Figure 7-9: Nicho Area Chloritized Andesite with Hydrothermal Brecciation. Breccia Cemented with Dark Specular Hematite, Whitish Euhedral Pyrite, and Yellow Chalcopyrite.

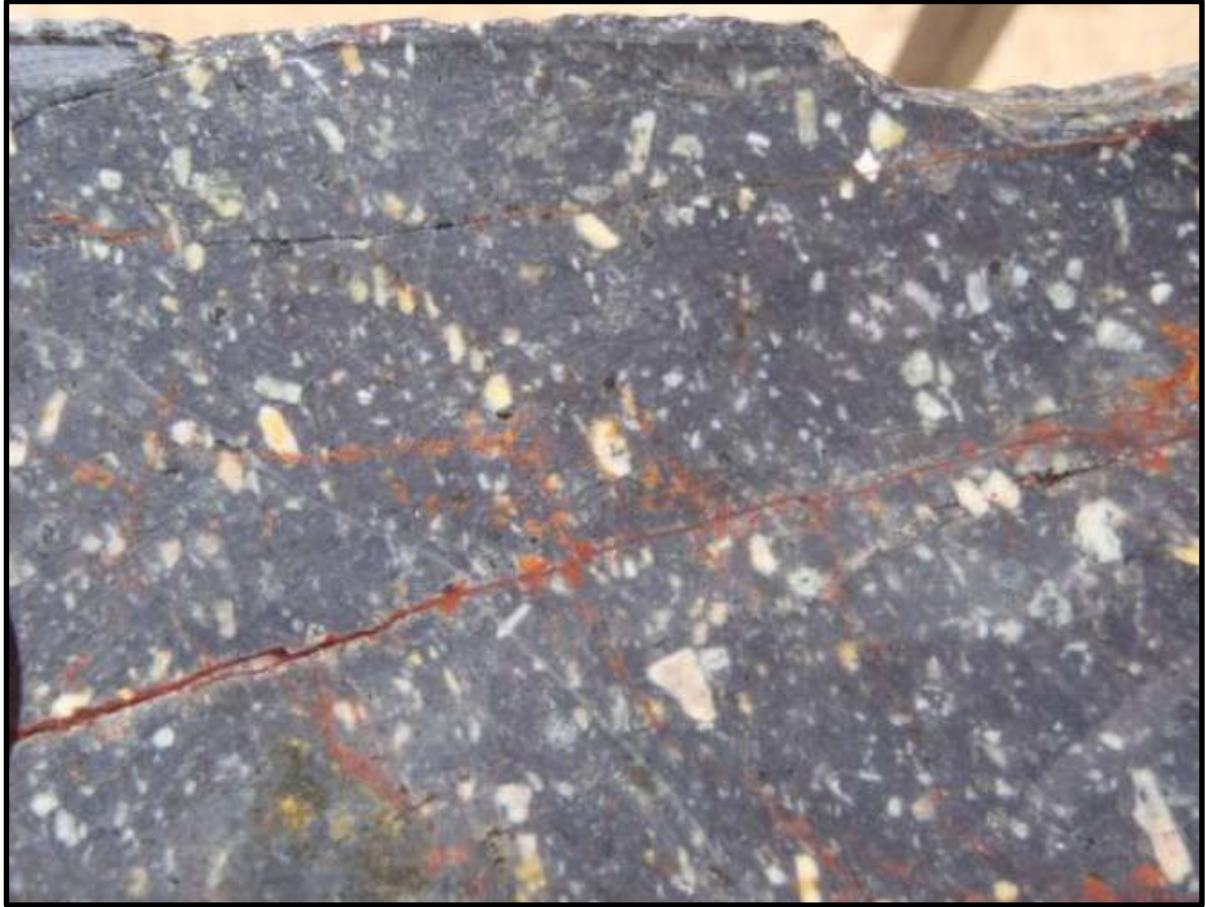
Figure 7-10: V12 Porphyritic Dacite Flow (Flow Texture is Not Apparent in this Rock Unit, S10-43D at 201 m)

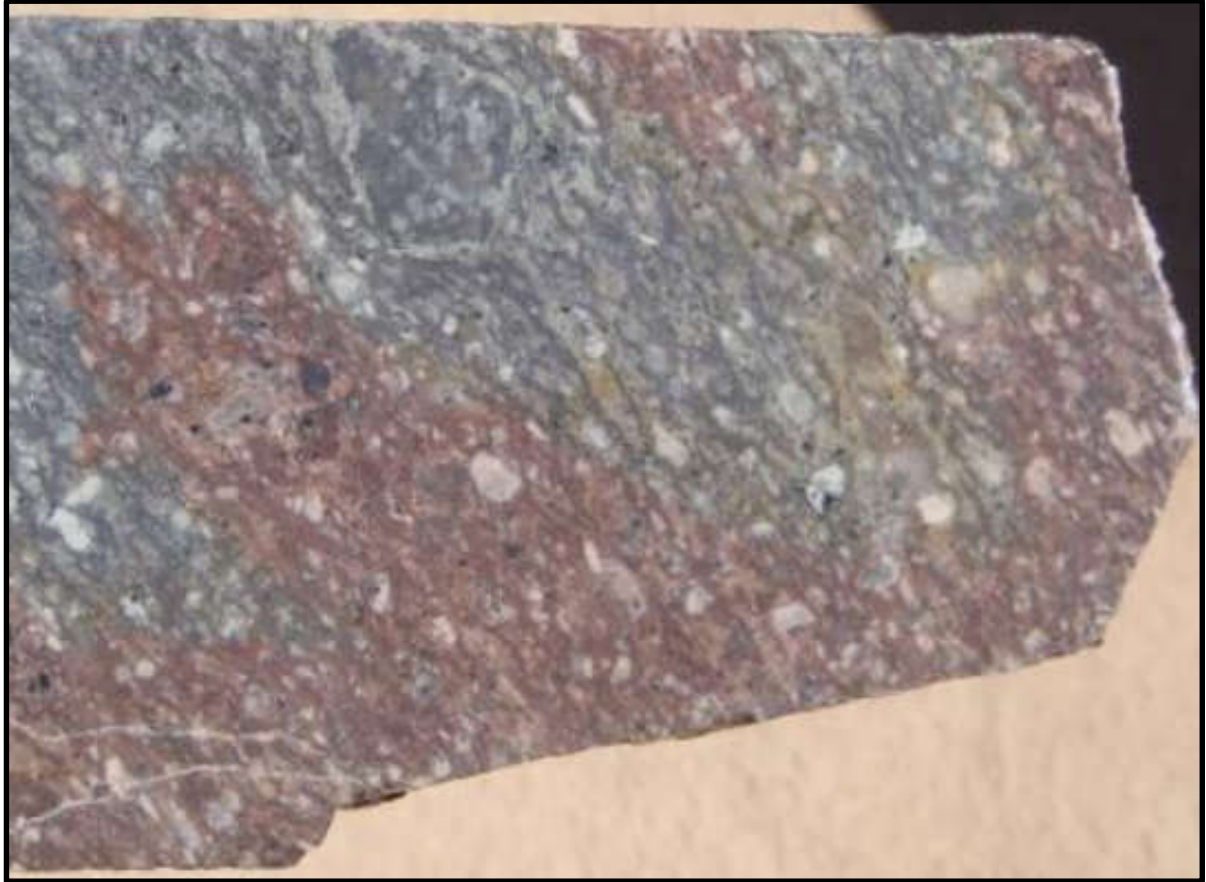
Figure 7-11: V13 Dacite Flow with Incipient Sericitic Alteration of Feldspars and Silicification Along the More Apparent Flow of Banding of the Felsic Unit. Porphyritic Texture is Decreasing. Note the Clasts of Volcanic Composition Within the Flow.

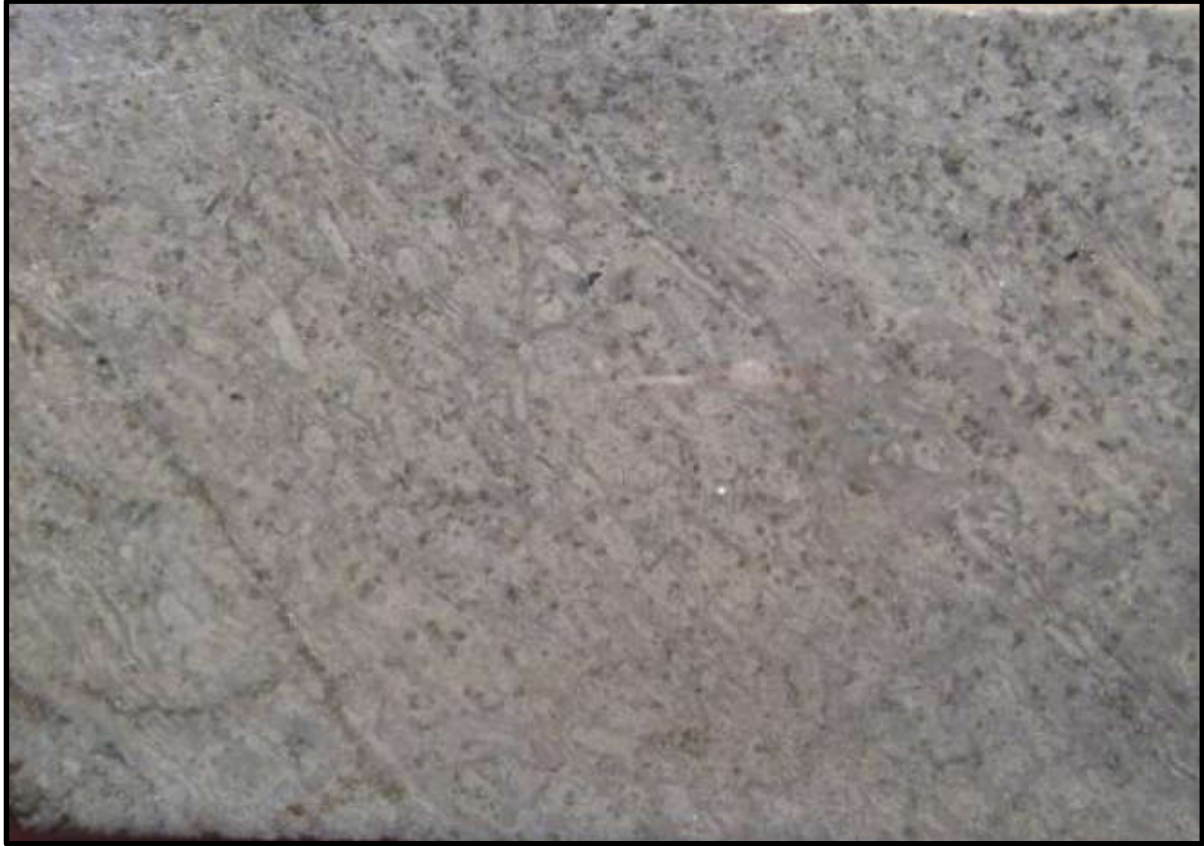
Figure 7-12: V14 Dacite Flow with Strong Sericitization of Feldspars and Silicification Along Flow Banding. Abundant Pyrite Disseminated and in Veinlets (S10–43D at 161 m).

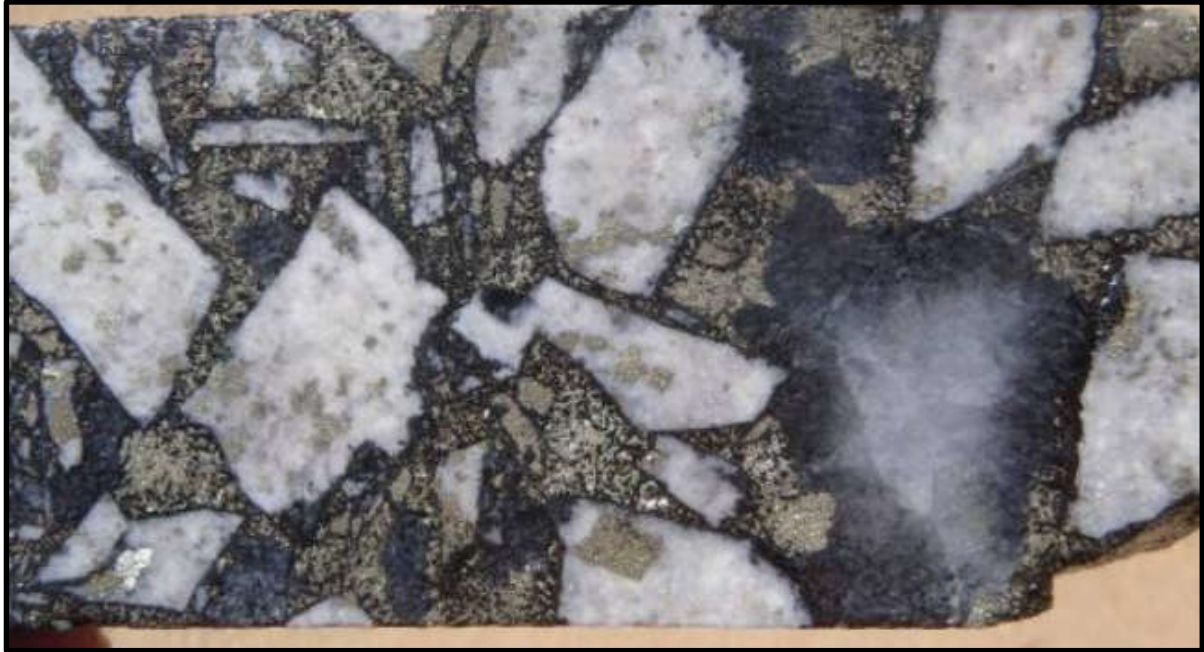
Figure 7-13: Quartz–Tourmaline–Pyrite Breccia with Clasts of Sericitized Monzodiorite Cemented by Sulphides and Minor Tourmaline (S11–122D at 275 m)

Core logging revealed that the hydrothermal activity took place during two separate phases or events. The first phase produced the hydrothermal breccias with a matrix of quartz, pyrite, and tourmaline. A second phase invaded the breccia, reopened veinlets, and precipitated chalcopyrite and calcite (Figure 7-13). Locally, it is observed that pyrite in the breccia cement is replaced by chalcopyrite, and in other cases veinlets of pyrite–calcite–chalcopyrite cut the first phase of breccia mineralization.

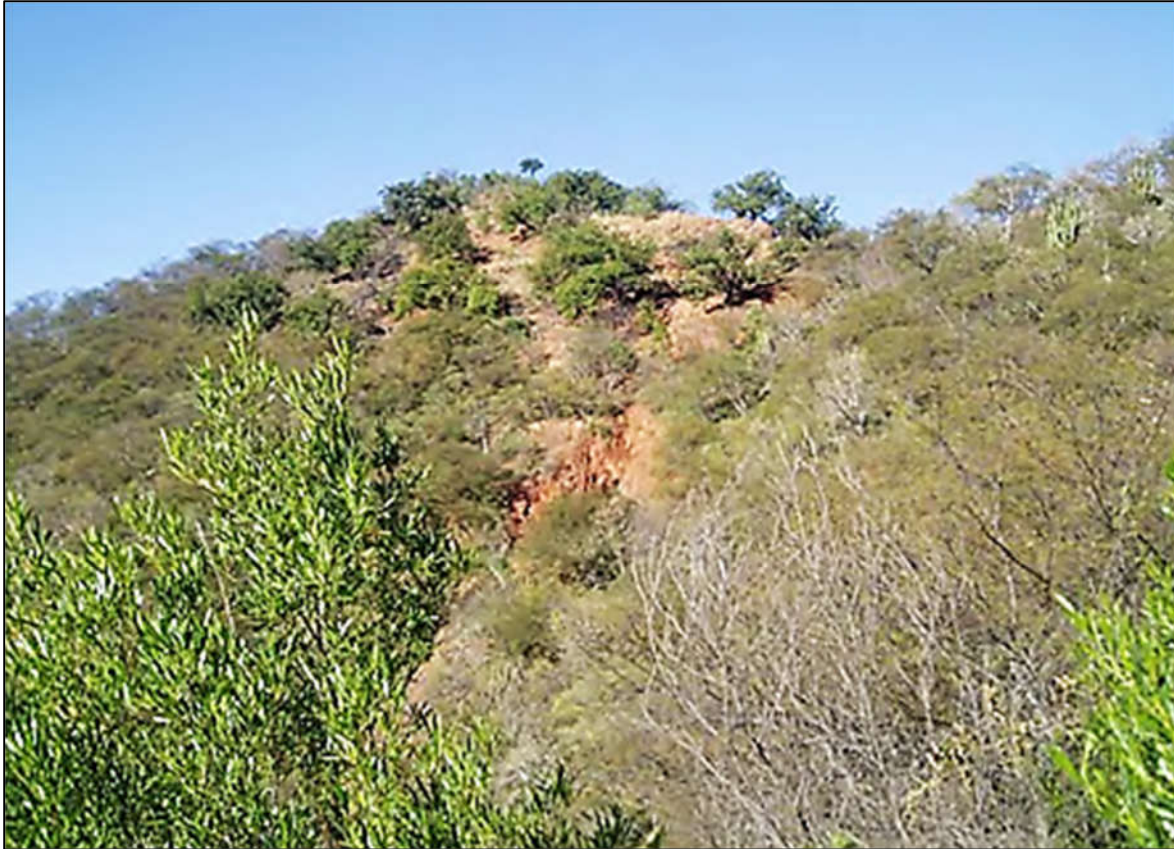
Figure 7-15: View Looking NW Down Strike of Structural Zone at Santa Lucia Area, Santa Lucia Mine Workings in Lower Midground

The Nicho Zone contains historical mine workings (the Santa Lucia mine) that were developed along a northwest high-angle structurally controlled zone of hydrothermal alteration and mineralization developed in andesitic volcanic rocks (Figure 7-15).

At the old Santa Lucia mine workings, historical production came from a zone of intensely iron-oxide stained, specularite-veined, sericitized andesite (Figure 7.15). Stope widths are as much as 10 m (Figure 7.18) within a broader zone of pervasive hydrothermal alteration.

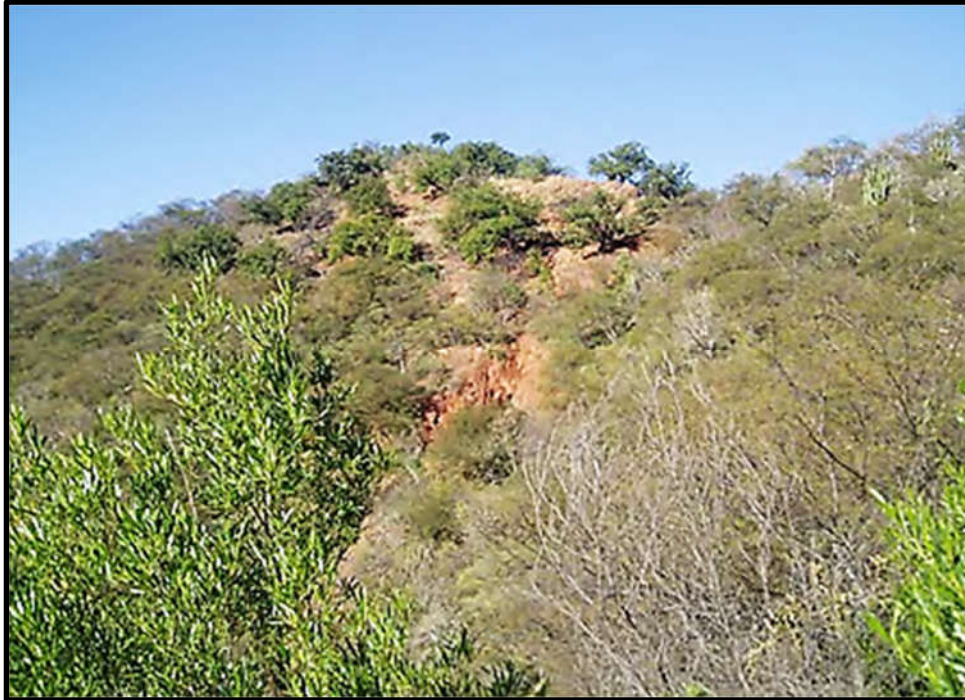
Figure 7-17: View Looking Northwest Down Strike of Structural Zone at Nicho

Note: Historical mine workings in lower midground of photo.

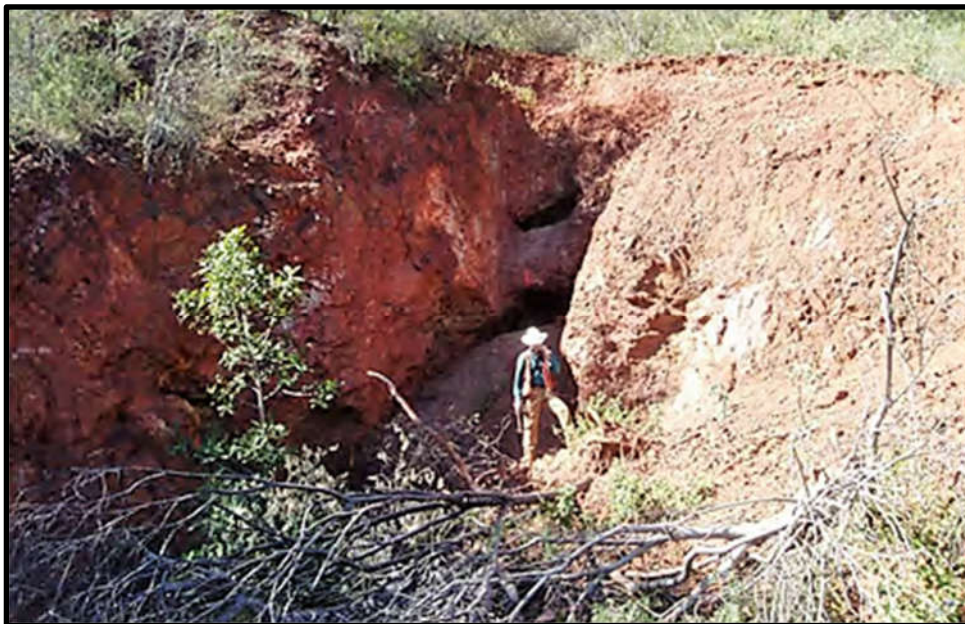
Figure 7-18: View Looking Northwest Down Strike of Structural Zone along the Santa Lucia Mine Workings

Note: Host rock is iron oxide stained and sericitized andesite with irregular stockwork speculative veins.

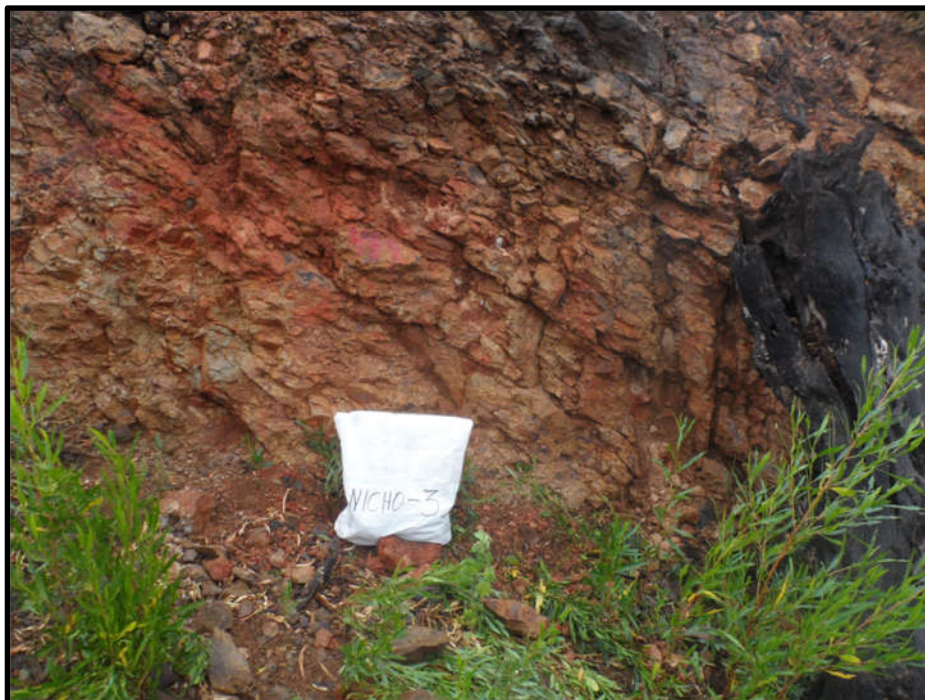
Figure 7-19: Nicho Zone—Clotty Irregular Specularite Veined, Chloritized Andesite

Note: Specularite veined rock is not pervasively sericitized. Sample 3 had a gold grade of 0.39 g/t.

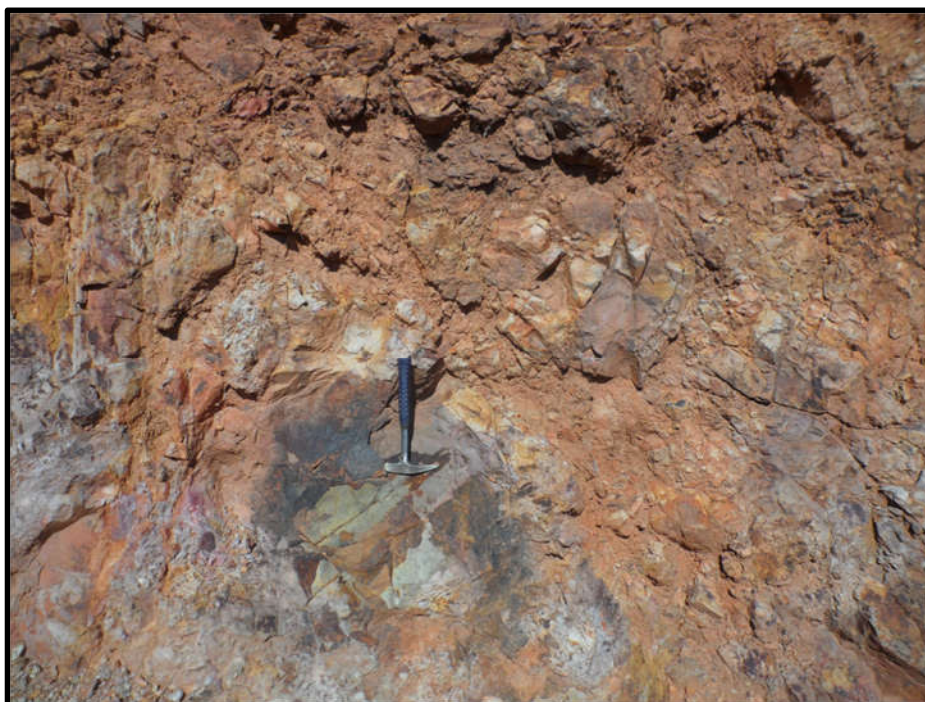
Figure 7-20: Nicho Zone Breccia with Subangular Andesite Fragments

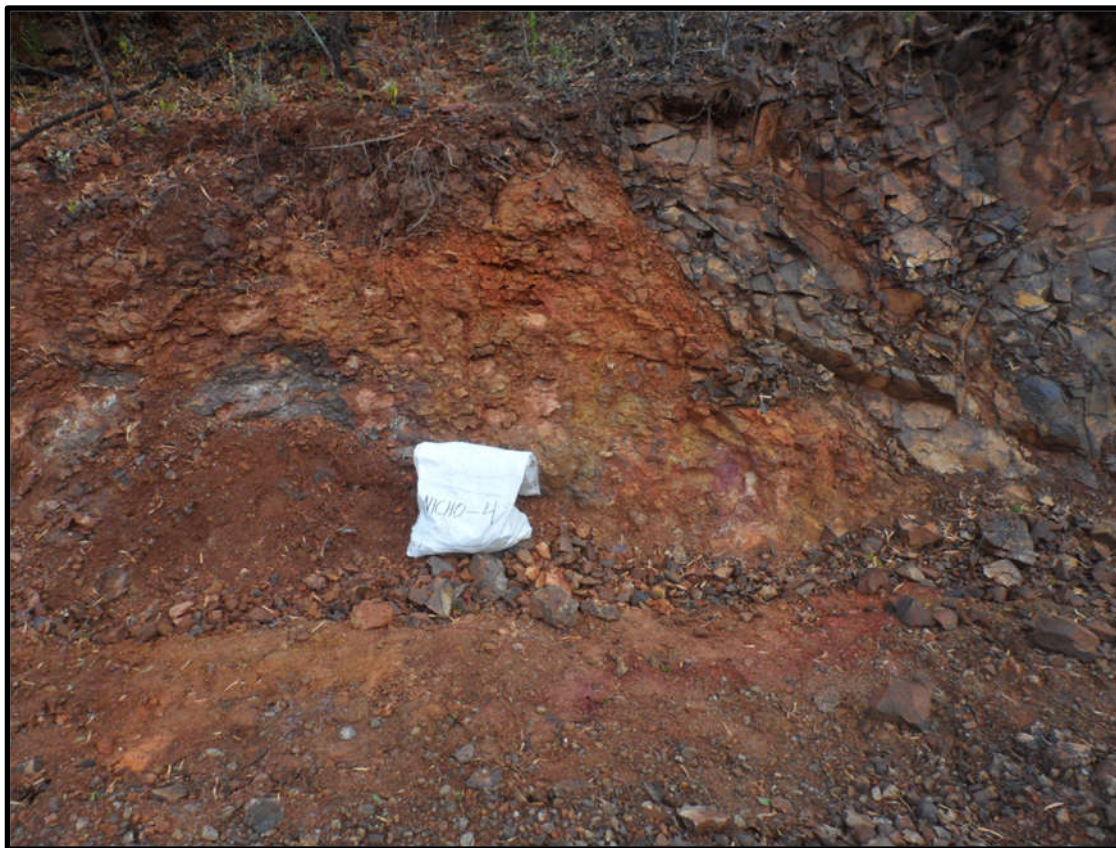
Figure 7-21: Andesite Breccia with high grade gold. Sample MC-513 2.96 g/t Au

Note: Minera Alamos, Sample MC-513

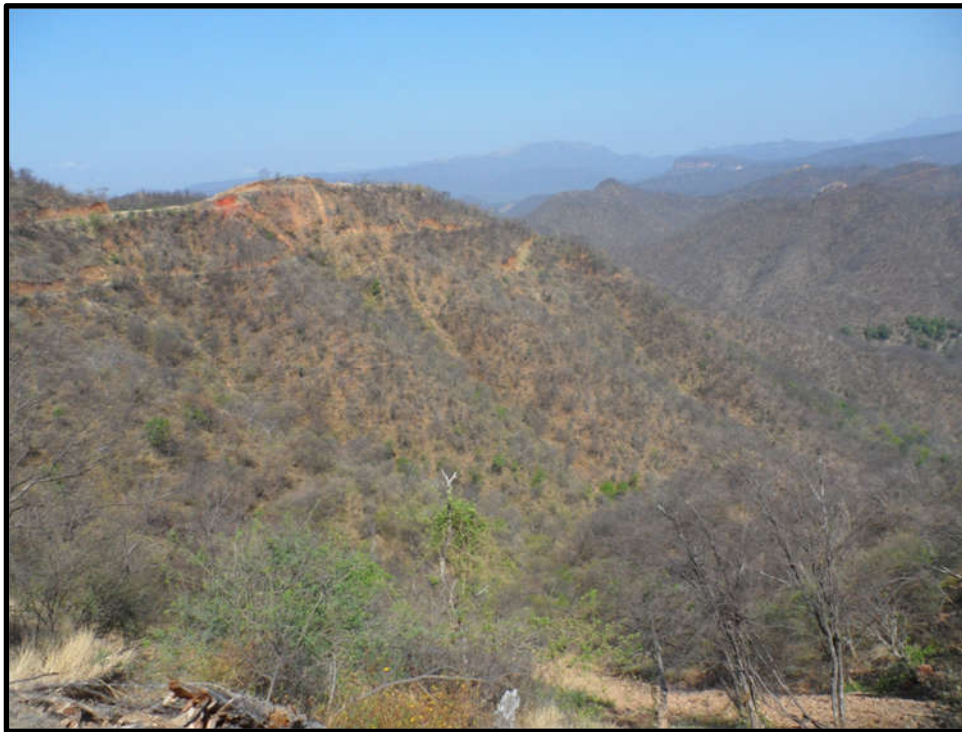
Figure 7-22: Nicho Norte Zone (View Looking North–Northwest)

Note: Minera Alamos, Nicho Norte was mined by Corex as part of its test mining program.

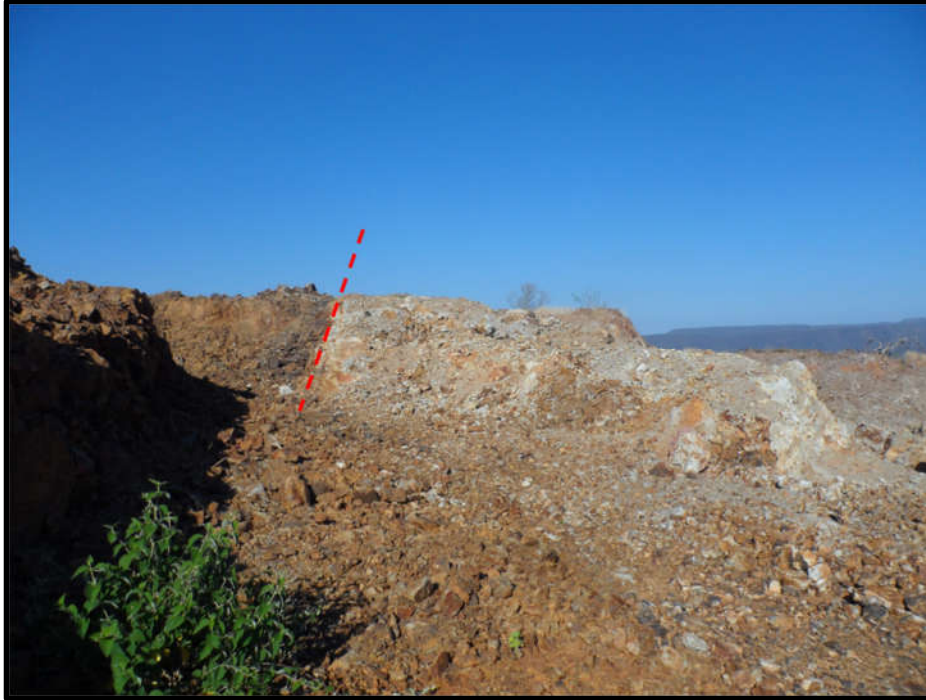
Figure 7-23: Nicho Norte Test Pit Showing Sub-Vertical Contact Between Andesite Tarahumara Formation (left) and Aplitic Porphyry QFP (right)

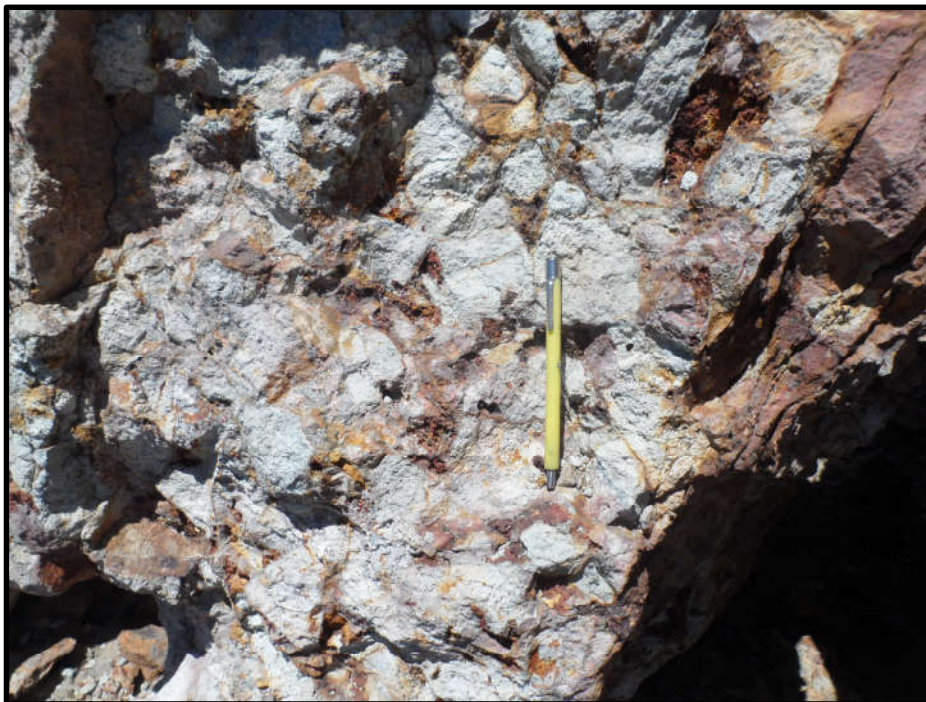
Figure 7-24: Nicho Norte Breccia Showing Fragments of Aplitic Feldspar Porphyry (QFP) Cemented by Quartz Calcite Veins

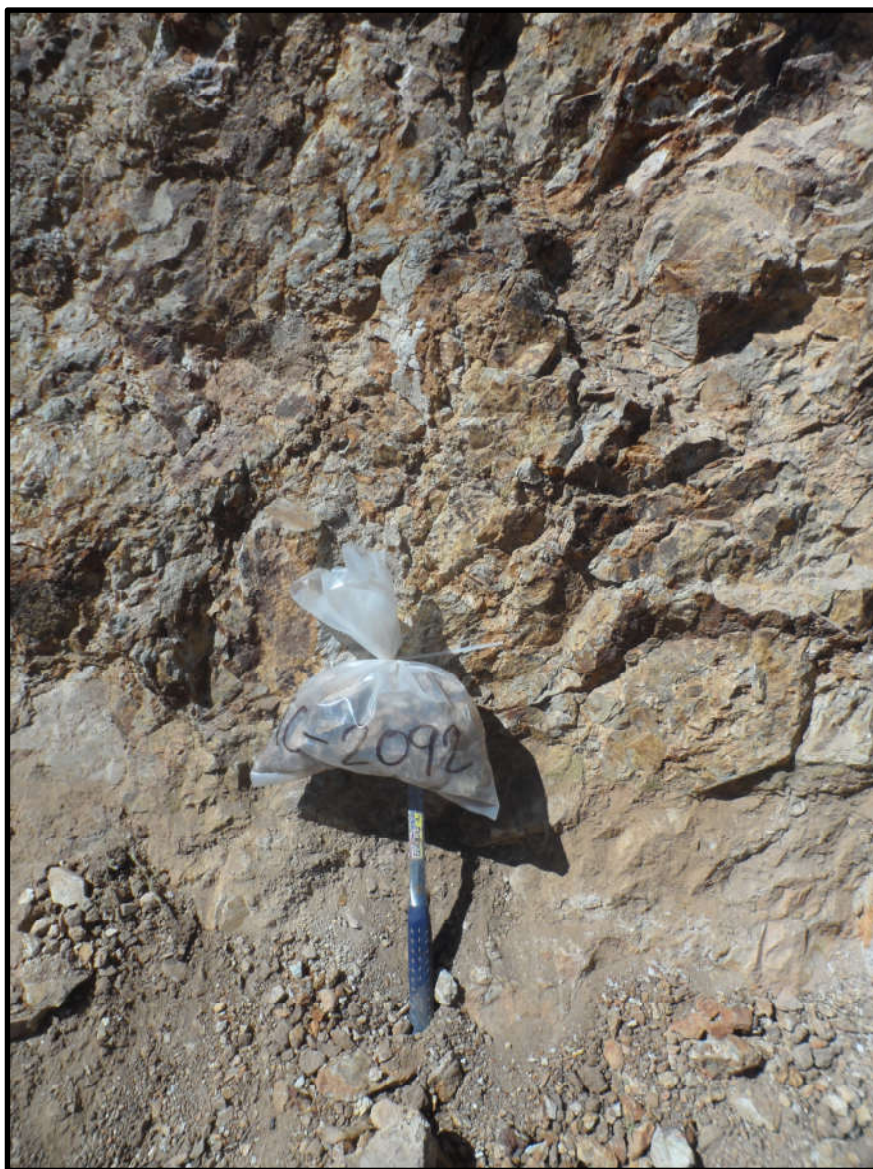
Figure 7-25: Nicho Norte—Sample MC-2092 (0.64 g/t Au) Taken From a Road Cut

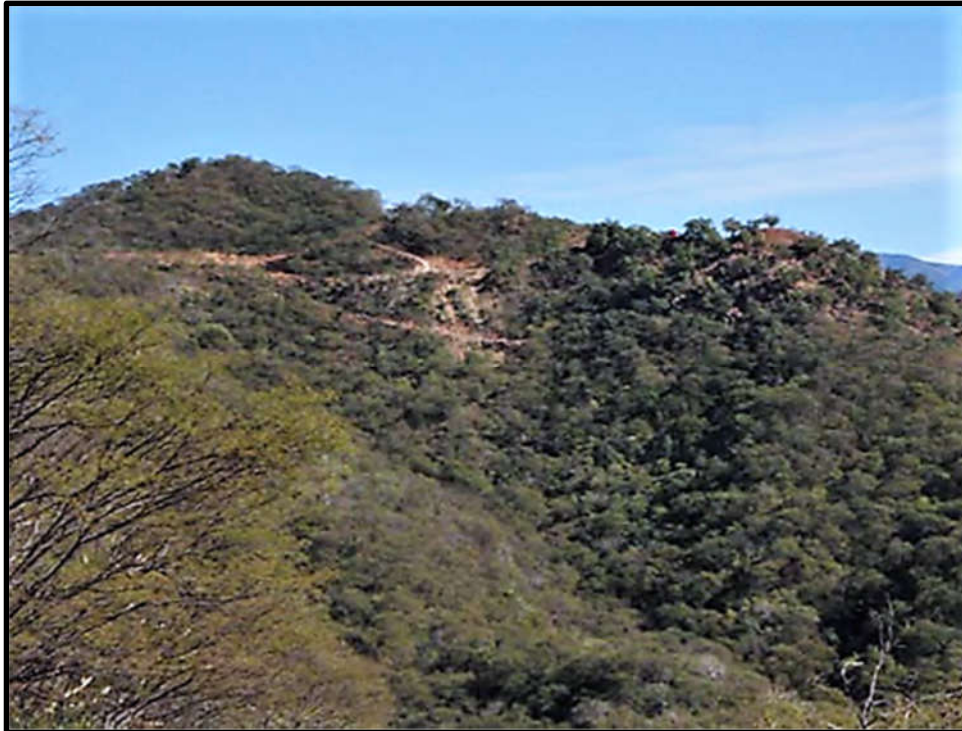
Figure 7-26: Divisadero Looking East–Southeast

Note: Minera Alamos, Divisadero alteration zone manifested by bleached and iron-oxide-stained rock outcrops and red-brown soils.

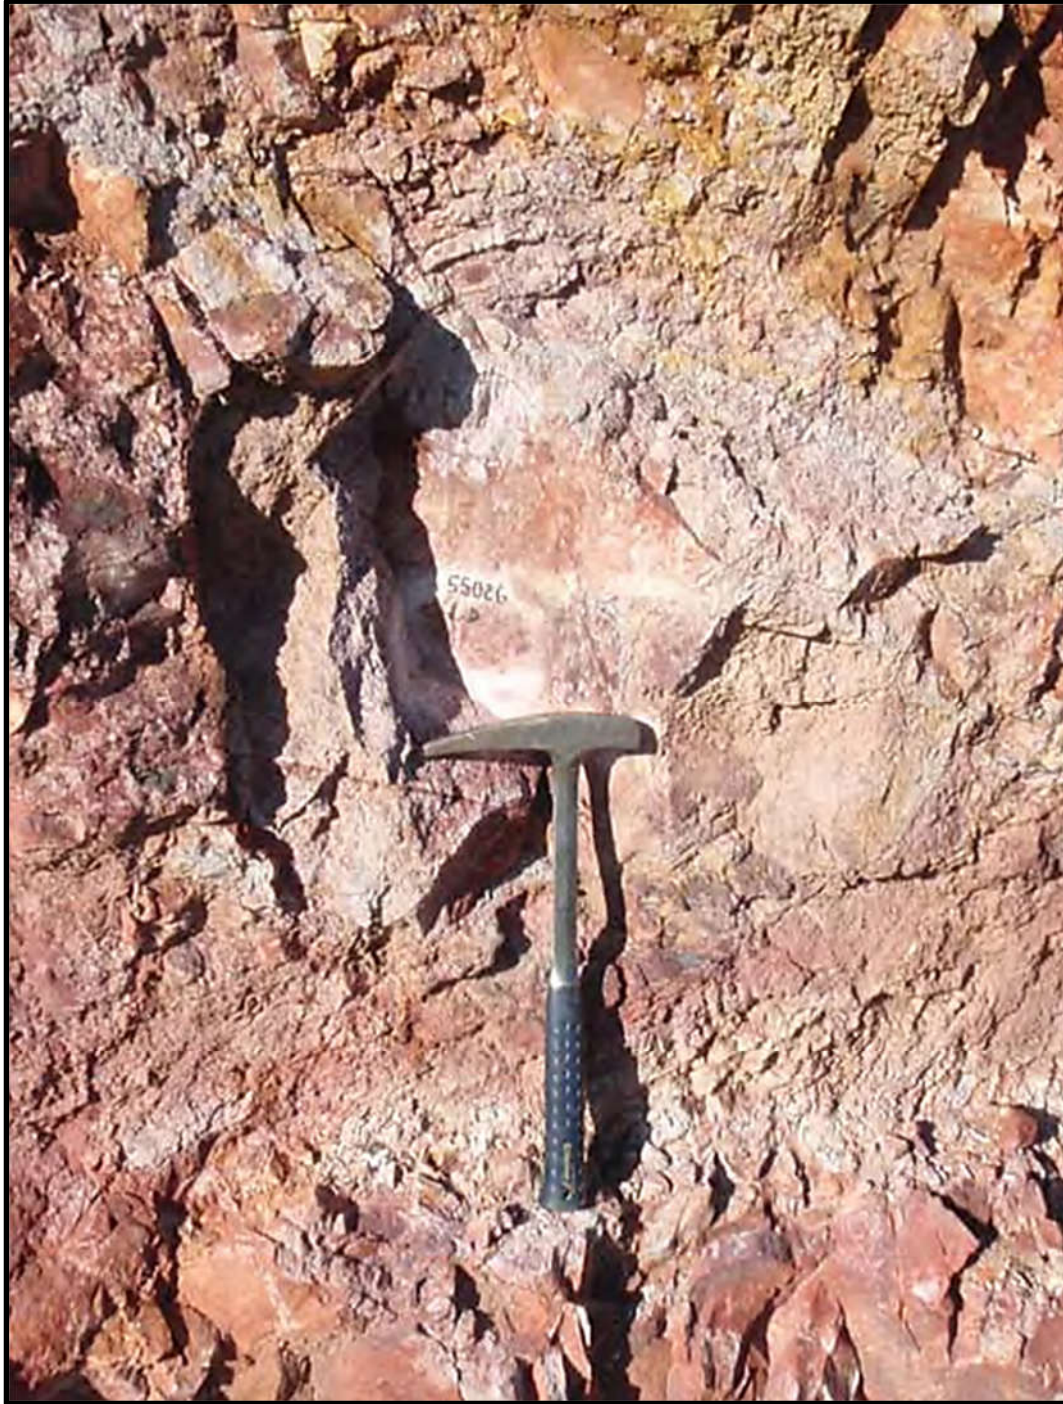
Figure 7-27: Divisadero Road Cut Exposure of Sericitic, Silicified, Iron-Oxide Stained, and Specularite Veined, Quartz Feldspar Porphyry in Drillhole SR09-27, Which Intersected 80.8 m at 0.74 g/t Au and 1.2 g/t Au

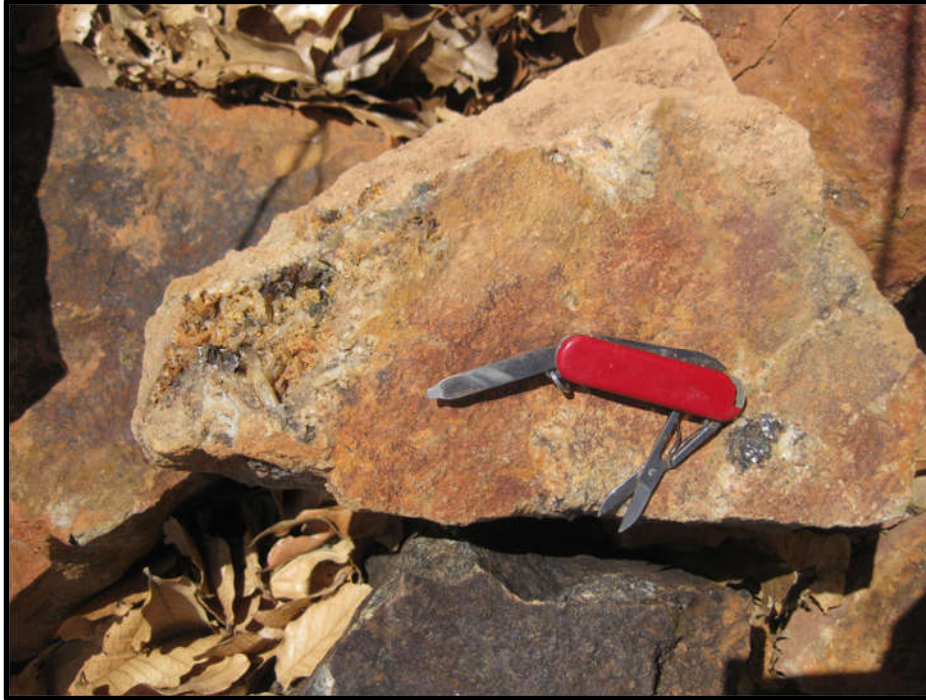
Figure 7-28: Divisadero. Cavities Filled by Quartz and Sulphides in an Aplitic Porphyry Rock (QFP)

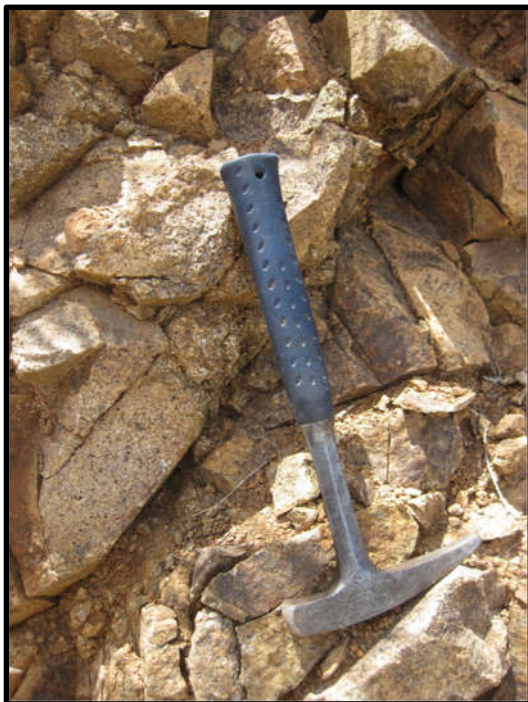
Figure 7-29: Quartz Monzonite (St. Nicolas Batholith). Host Rock to the Divisadero QFP (Aplitic Porphyry)

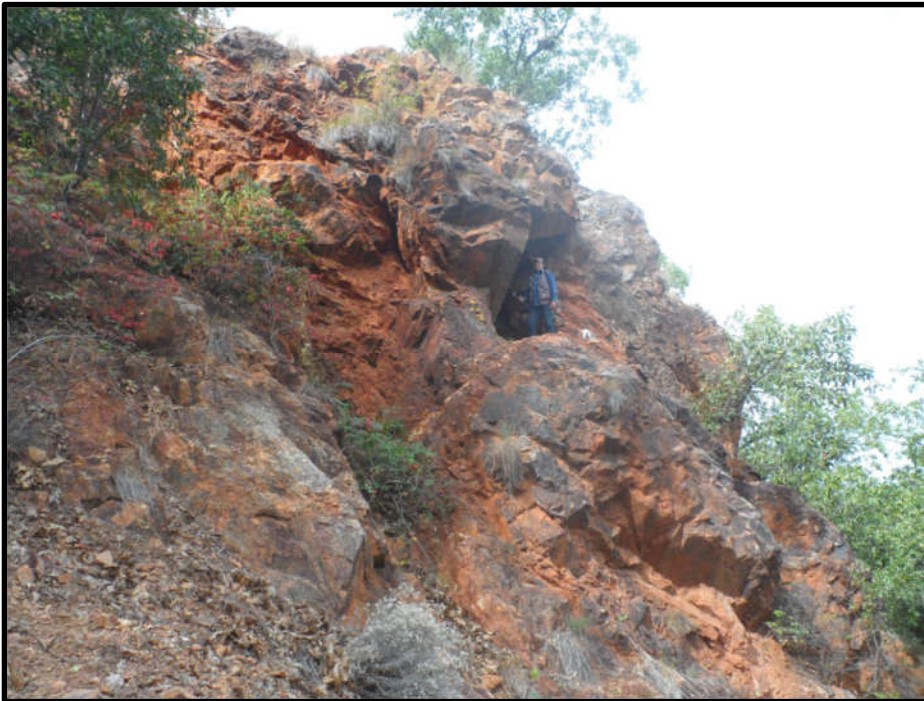
Figure 7-31: Benjamin, View of an Outcrop Looking Southwest. Sample MC2011 Grading 0.537 g/t Au from Andesite Breccia

The Benjamin zone differs from the other known mineral occurrences because gold mineralization is also accompanied by significant copper and silver concentrations. At Benjamin, an intensely fractured, locally brecciated zone of pervasively sericitized and pyritic andesite outcrops (Figure 7-31), and in contrast to other mineralized zones at the Santana Project, specularite veinlets were not observed. Small prospects in the Benjamin area were developed on northeast-striking fault and fracture zones, with the highest-grade portions of the soil-gold anomaly defining a crude northeast-trending zone. These fault zones with old workings are part of a larger gold-bearing breccia zone with hypogene pyrite, chalcopyrite, and tetrahedrite hypogene mineralization that was affected by supergene alteration, forming an upper leach cap, a transitional supergene copper-enrichment zone, and a lower, unoxidized-sulphide zone. A quartz crystal-bearing rhyodacitic/rhyolitic tuff locally overlies oxidation of pyrite that is, or was, present in the altered zone, both as disseminations and in veinlets. A coincident soil and rock chip gold anomaly of >0.3 g/t of approximately 9 ha is centered around the Benjamin hill and is part of a larger >0.10 g/t Au soil anomaly. Currently available data is not yet sufficient to define the final 3-D geometry of the mineralization or the distribution of gold, copper, and silver. There has not been any recent drilling within the extents of the Benjamin zone at the effective date of this report.
