NI 43-101 Technical Report Mineral Resource Estimate for the Santana Project Sonora State, Mexico

Minera Alamos Inc.

Effective Date: May 31, 2023

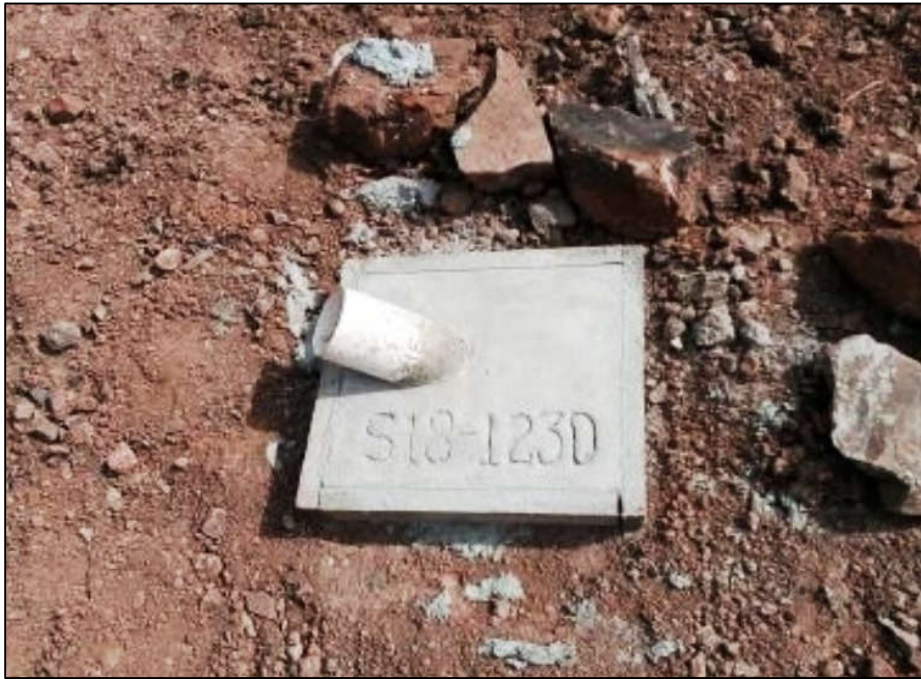
Figure 10-5: Typical Collar Completion at the Project

Drillhole collar locations were established in the field using GPS units and marked with wooden stakes. Drillhole alignments were achieved using both fore sight and back sight markers to ensure the drillhole was on the planned bearing. A field geologist was at the rig to help the drillers align the rig to the planned bearing and dip before commencing drilling. After the drillhole was completed, the collar location was marked with a cement monument that enclosed a piece of PVC pipe that shows the bearing and dip of the hole. The hole number was engraved into the cement for future reference (Figure 10-5: Typical Collar Completion at the Project).

Drillhole collar locations were established by field GPS unit and marked prior to drilling with wooden stakes. A line of the hole was marked by two stakes showing the fore sight and back sight, both of which were used to establish the hole's bearing. A field geologist was at the drill rig during alignment and doubled-checked the hole's bearing and dip prior to the start of drilling. Once a hole was finished, the collar location was marked with a concrete monument. The hole number was inscribed into the cement and a piece of polyvinyl chloride (PVC) pipe was added to show the dip and bearing of the hole (see Figure 10-5).

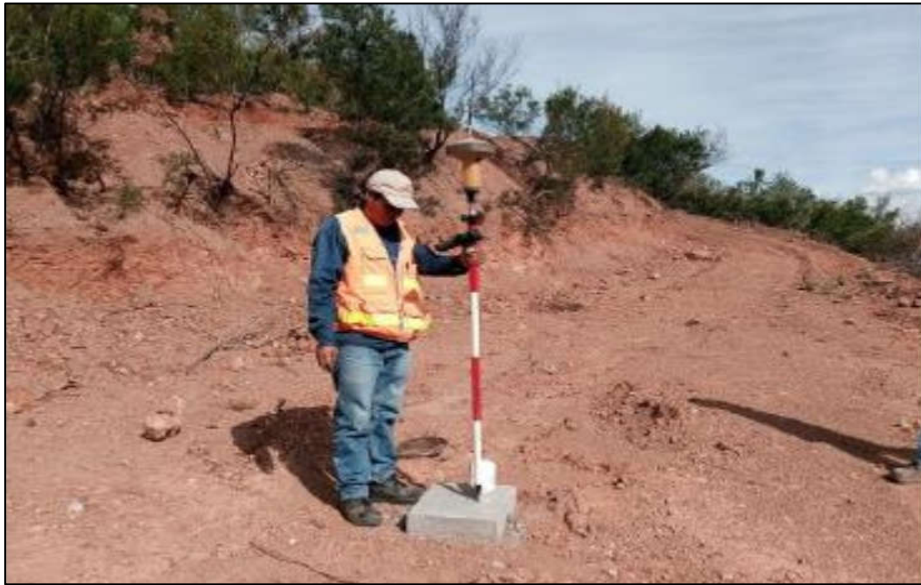
Figure 10-6: GEO Surveying the Location of Drillhole S18

Figure 10-6 shows the GEO surveyors completing a survey.

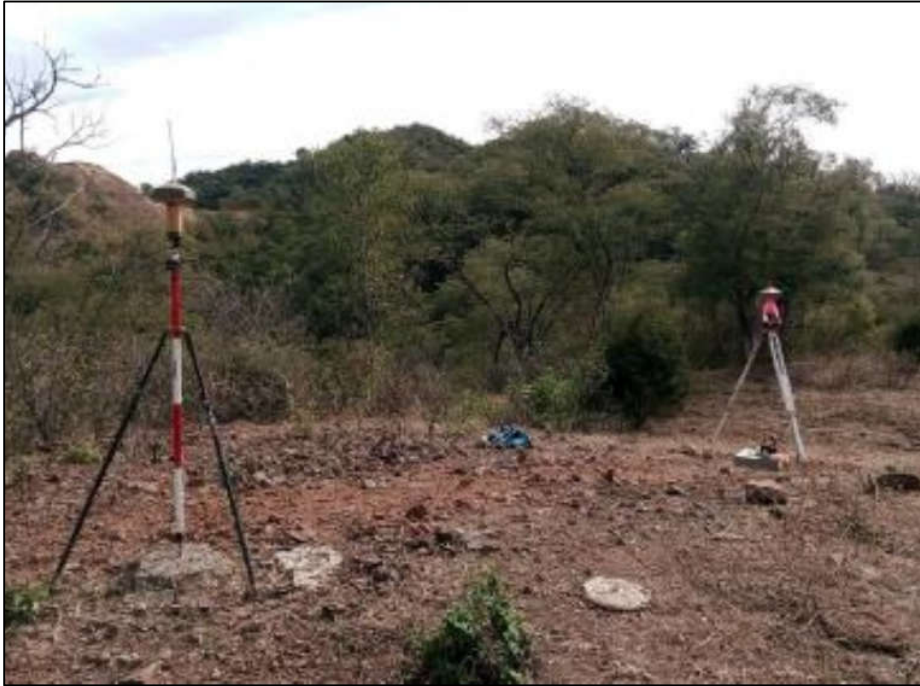
Figure 10-7: Surveying Site Control Points

GEO Digital also located and surveyed four base control-points for use as survey tie-in points for construction and mine production purposes. These control points are located at the top of two hills (one by the Nicho Zone and the second by the Nicho Norte Zone) and are in pairs, as show in Figure 10-7. The coordinates of these control points are given in Table 10-8.

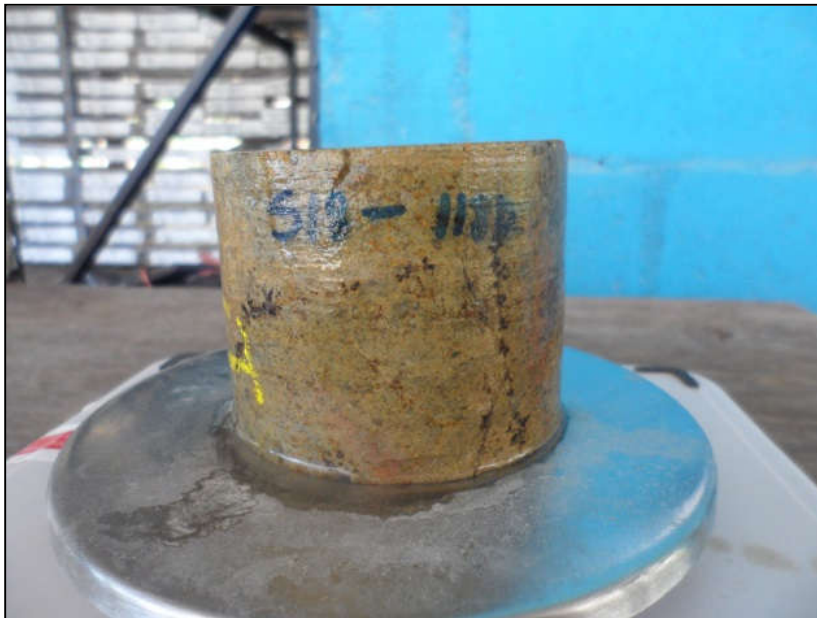
Figure 10-8: Photograph Showing a Density-Tested Sample

Minera Alamos geologists completed density measurements on all drillholes completed after 2018. The density of each sample was measured using the caliper method, which determines the density by measuring the mass and volume of each sample on full core samples that have a length of 5 cm and are free of fractures and excessive pores. Figure 10-8 shows a typical sample used for density measurement purposes, after preparation.

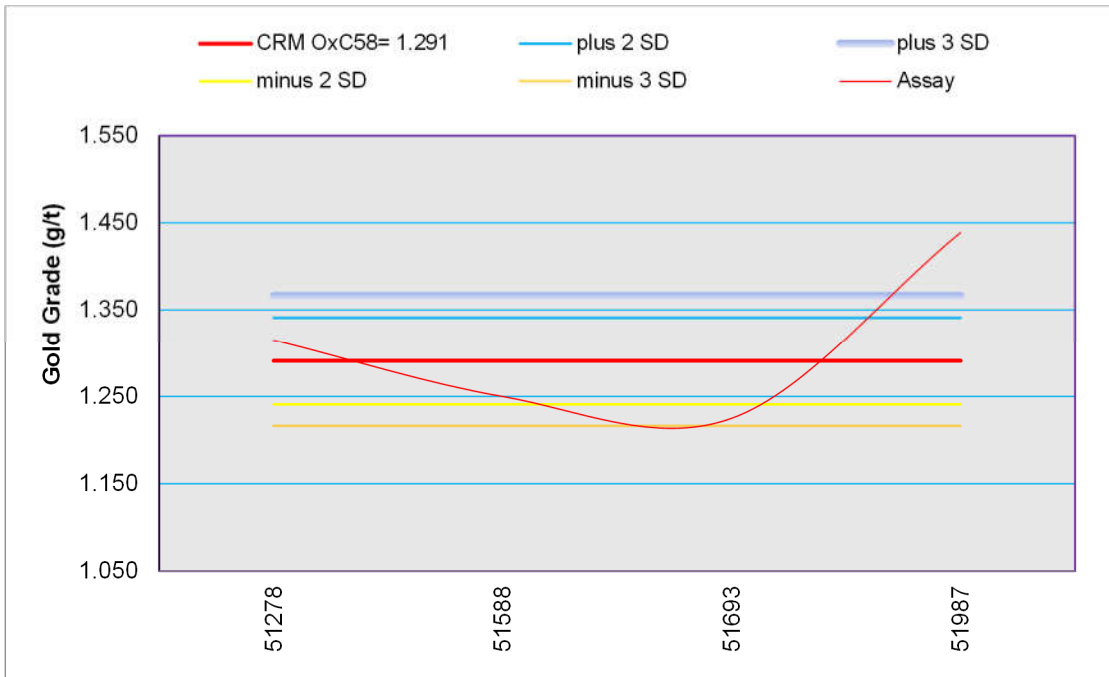
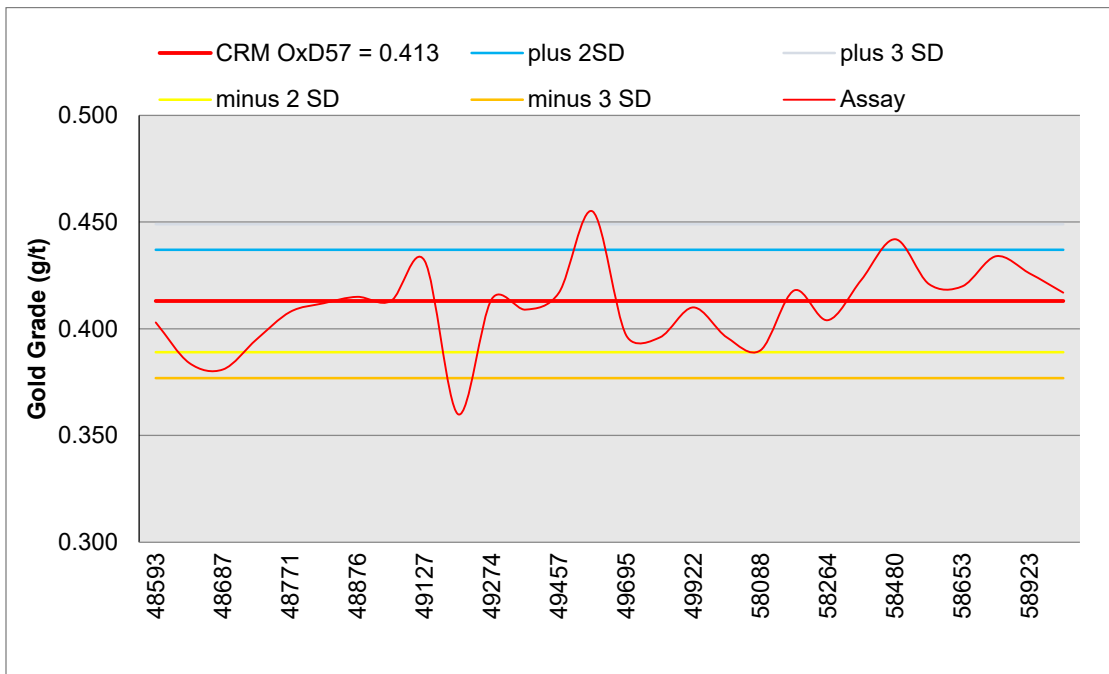
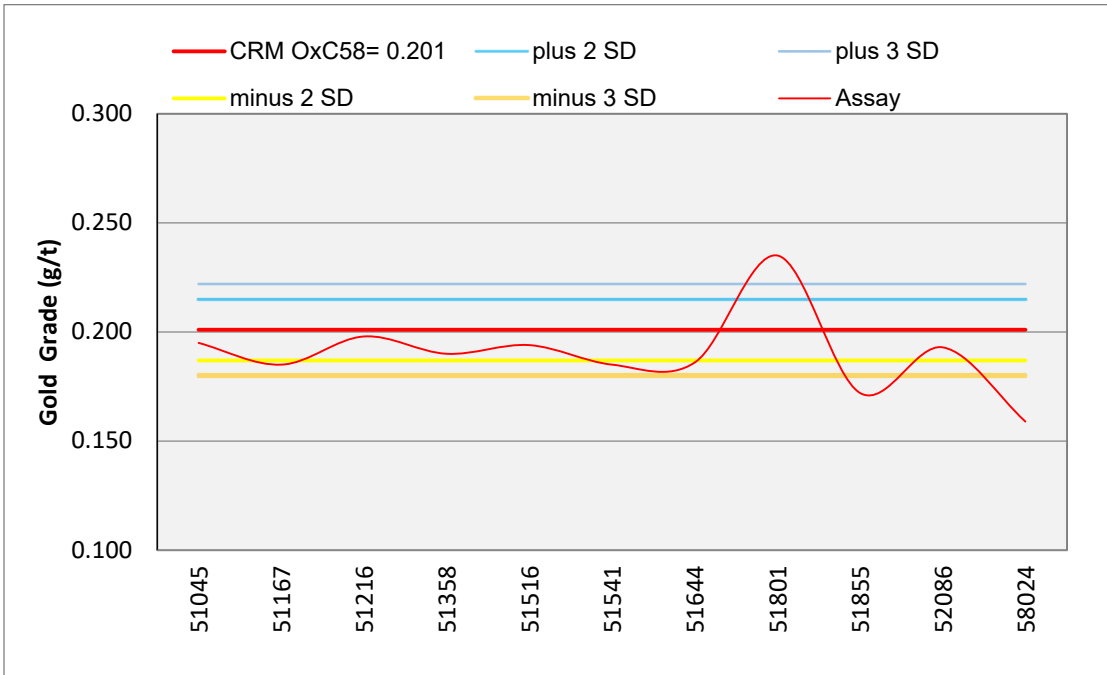
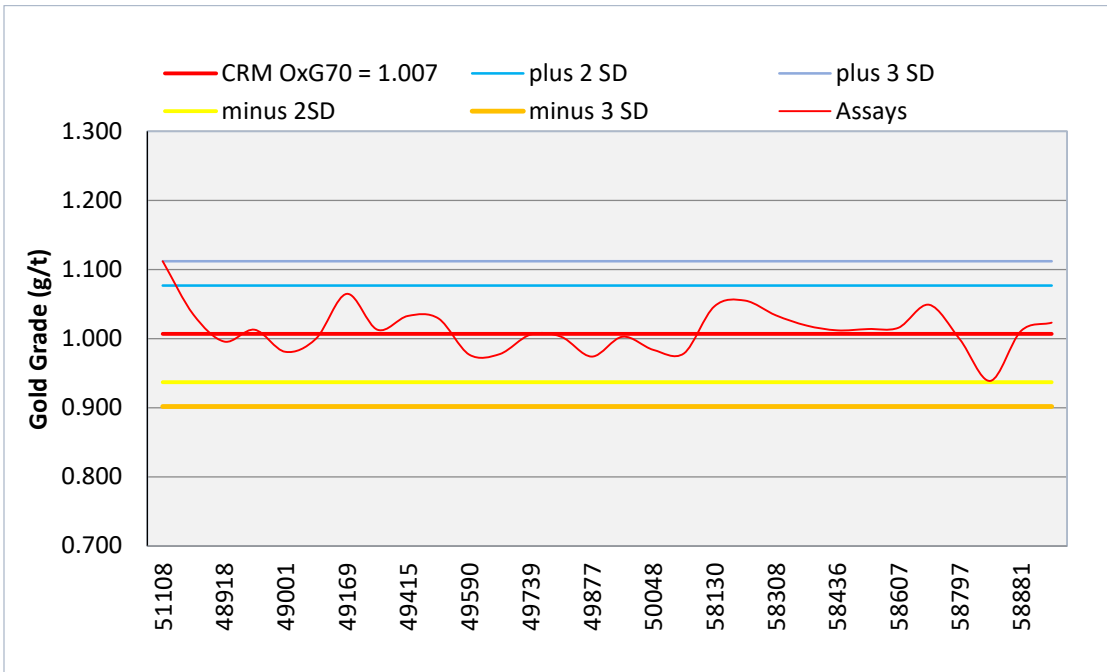
Geologists inserted a certified reference material (CRM) (or standard) every 50 samples, 79 standard samples were inserted over the course of the drill program. Of the 79 CRMs inserted into the sample stream, only six were out of range (i.e., greater than three times the standard deviation).

Figure 11-2 to Figure 11-5 show the standard assay grades received from the laboratories versus the known standard grade.

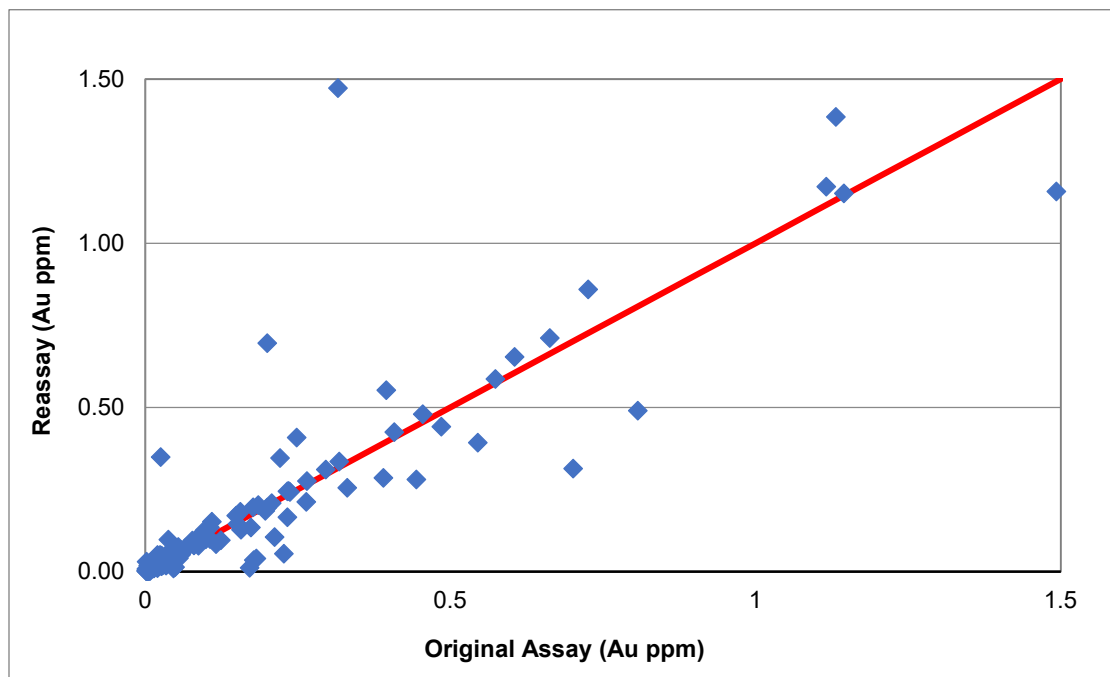
Figure 11-6: Original Assays vs. Duplicate Assay QQ Plot

Figure 11-6 shows a QQ plot of the duplicate versus the original assays. Based on the QQ plot, the duplicate sample program had a Pearson correlation coefficient of 0.870, which is considered acceptable.

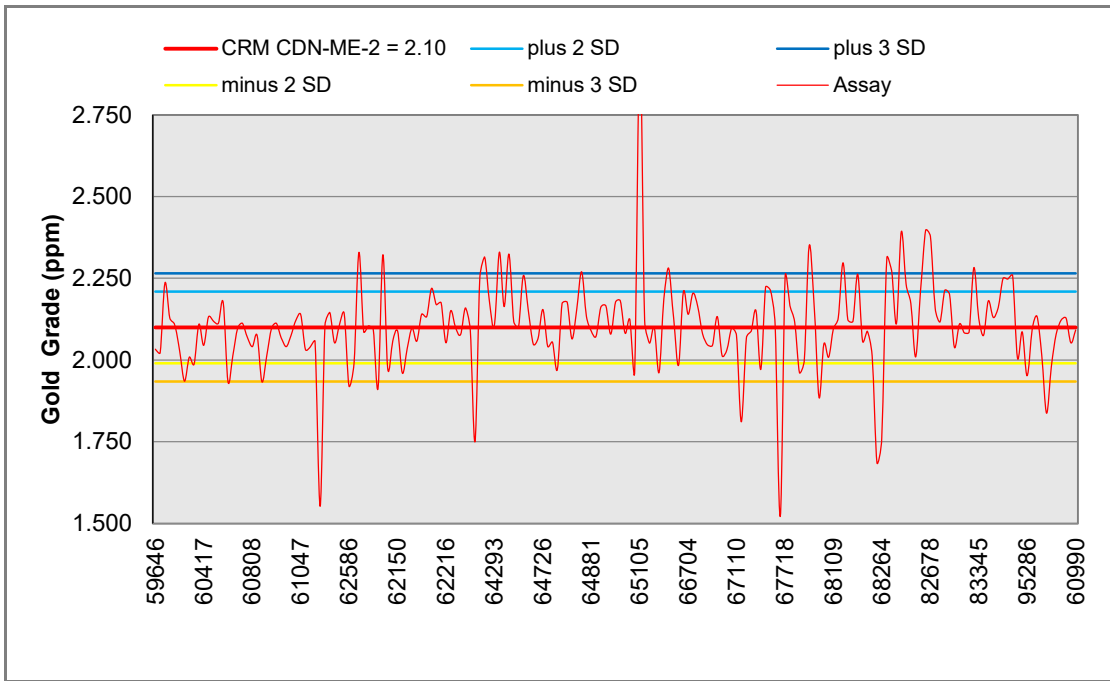
Standards were inserted after the 5th sample of each hole, then every 20 samples until the end of the drillhole. In total, 742 samples were inserted in the sample stream of the 2010–2011 drill campaign. Figure 11-8 to Figure 11-13 show the standard assays returned by CRM.

The CRM assay results show inferred accuracies that range from poor to moderate in the original assay sheets. GeoSpark Consulting reviewed this dataset in 2010 and provided two reports to Corex (Vallat, Caroline February and March 2010) titled Quality Assurance and Quality Control Report on the Project 2008 and 2009 Analytical Results. The conclusions from these reports are summarized at the end of this subsection.

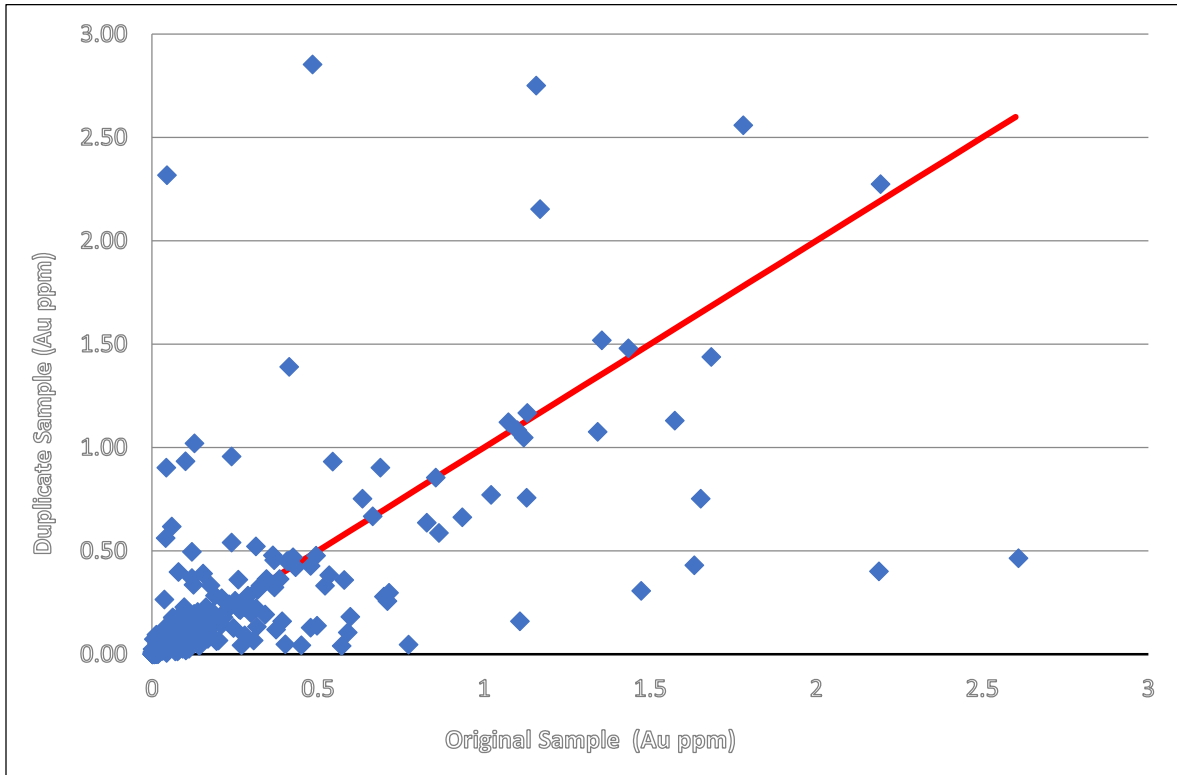
Figure 11-14: Core Drillholes Duplicate vs. Original Assays QQ Plot

Duplicate samples were taken from the 13th sample of each hole and named as the following sample. This process was then continued on every 20th sample. As part of the 2010–2011 core drilling campaign, a total of 537 duplicate samples were submitted for assay. The Pearson correlation coefficient was 0.766, which indicates a moderate correlation. The correlation is believed to be attributable to coarse-grained gold. Figure 11-14 shows a QQ plot of the duplicate versus original assays.

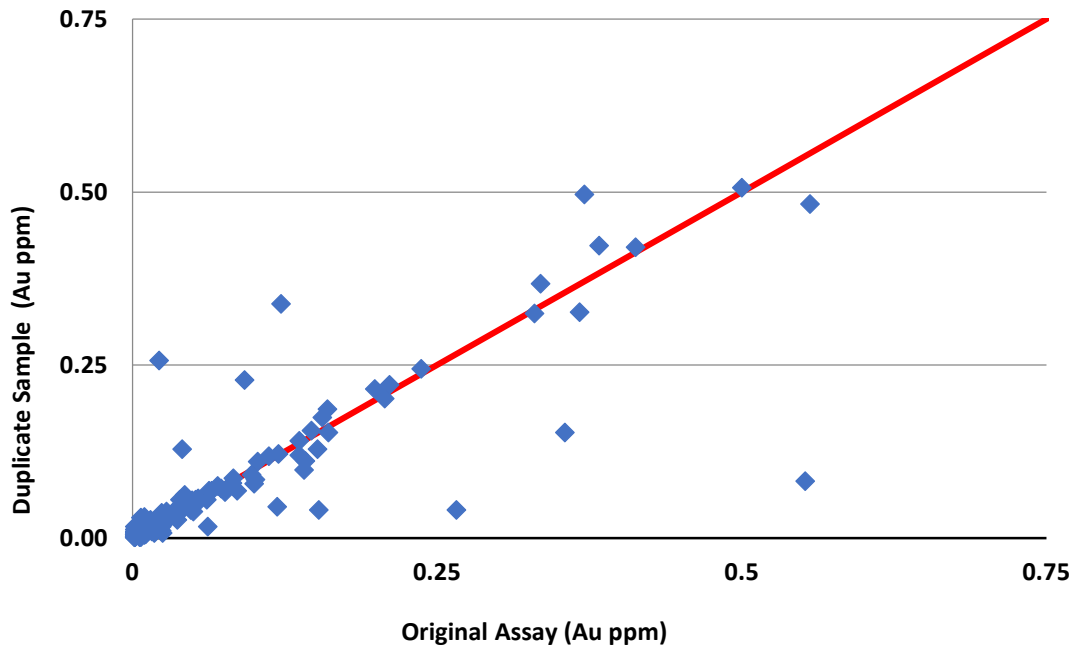
Figure 11-15: RC Drillholes Duplicate vs. Original Assays QQ Plot

Duplicate samples were added to the RC sample stream using the same methodology as that of the core samples described above. A total of 183 duplicate samples were added to the RC drilling sample stream. Based on a comparison of the duplicate to original assays, the data set was found to have a Pearson correlation coefficient of 0.968, which is excellent.

Figure 11-15 shows the duplicate versus original assays from the RC drillholes.

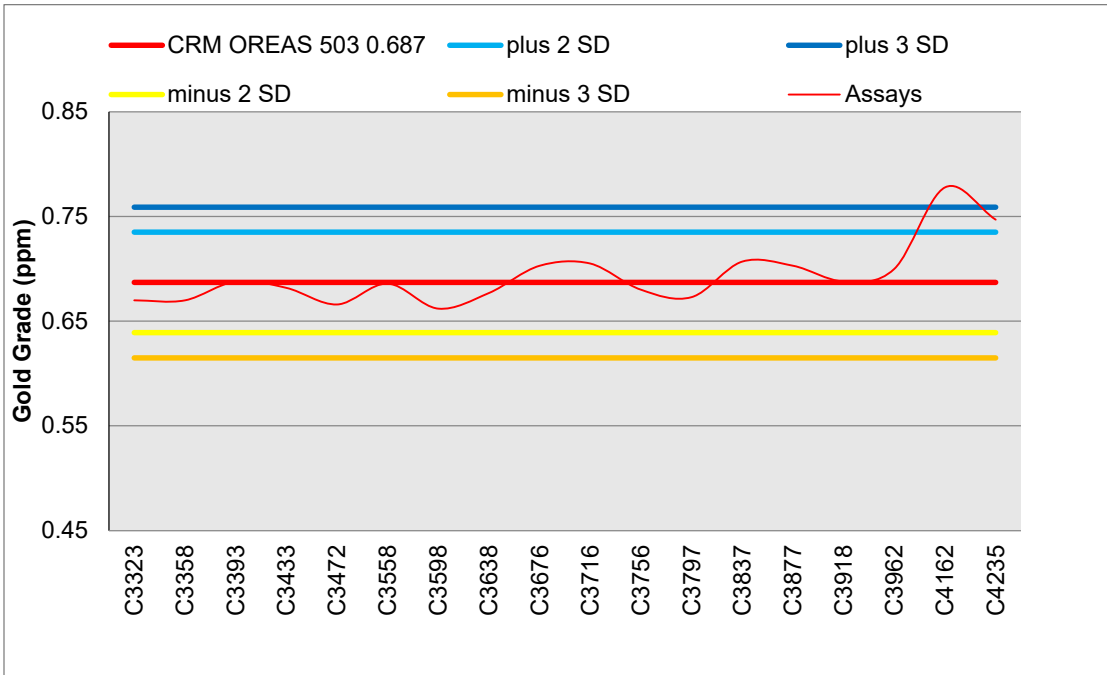
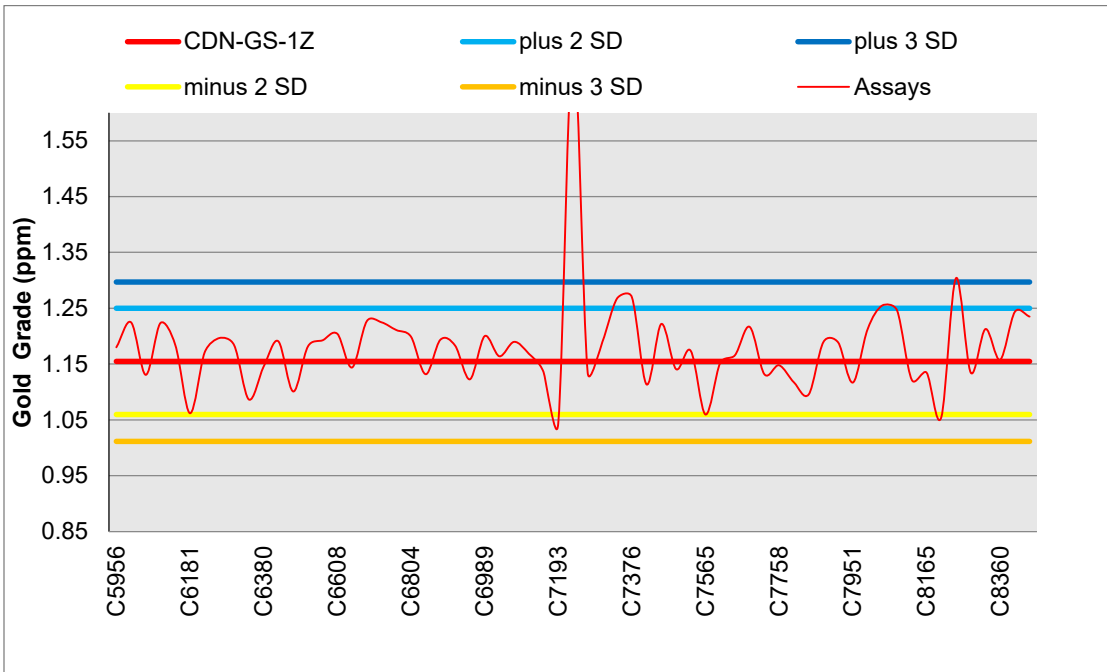
Figures 11-21 to 11-25 show the standard assays received from Bureau Veritas versus the known standard grade.

Of the 264 standard samples added to the assay stream, four were failed as they were greater than three times the standard deviation. These results can be attributable to coarse gold and the nature of the mineralization and are similar to results recorded during the 2010–2011 Corex sampling programs. It is the author’s opinion that the 2018–2021 sampling programs were conducted to industry standards.

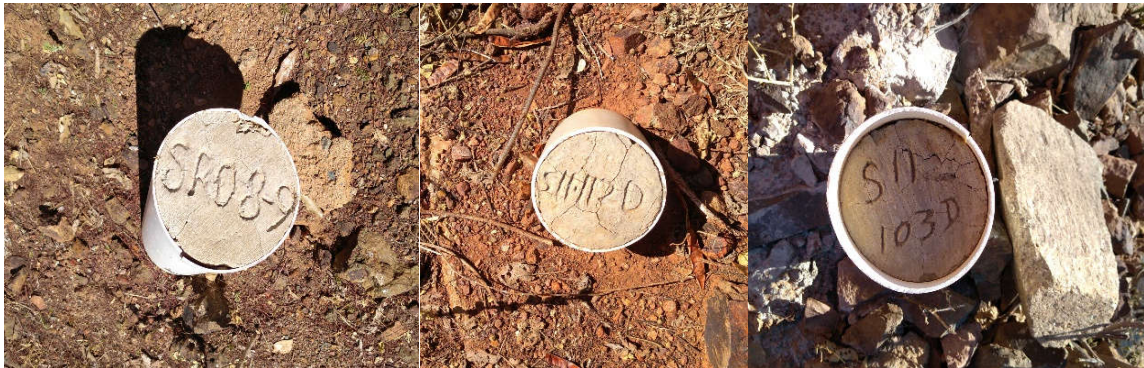
Figure 12-1: Select Drillhole Collars

The drillhole collar locations recorded in the database have all been surveyed using high-precision GPS. Data verification of the existing database began by checking the collar coordinates of some drillholes that the QP of this section randomly selected in the field using a hand-held Garmin GPS device. The drillhole collars were easy to find and were well marked by PVC pipe that was inserted and cemented into the drillhole casing. The hole number was engraved in the cement contained in the PVC pipe. Figure 12-1 shows a typical drillhole monument at the Project.

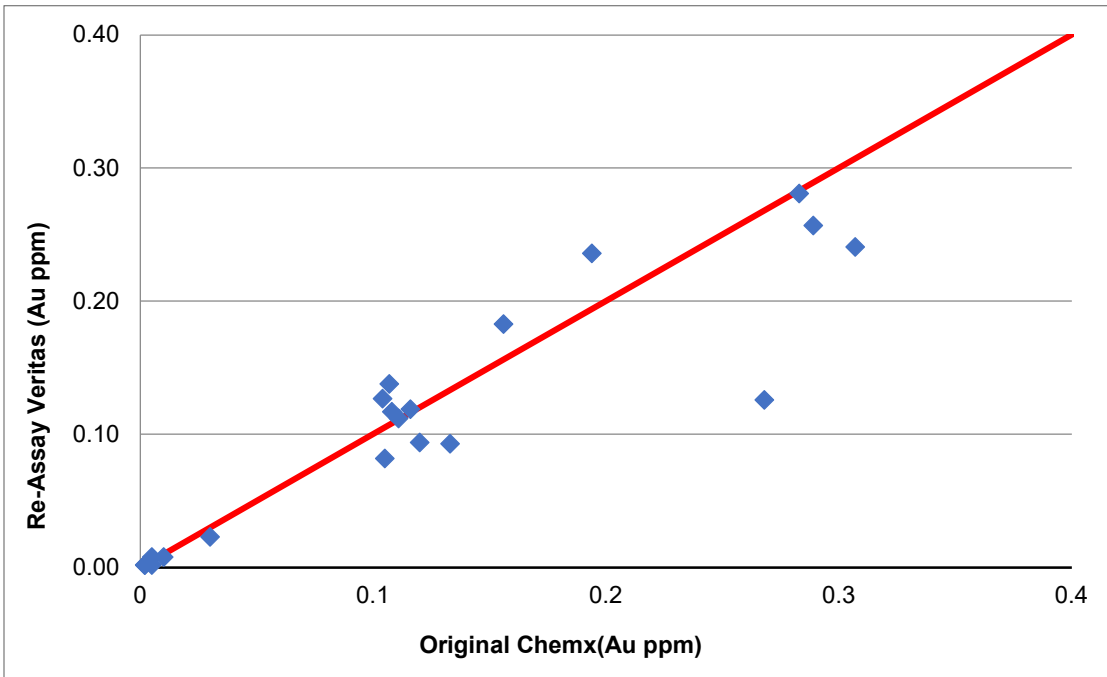
Figure 12-2: QQ Plot Pulp Assay Check, ALS Chemex Original Assays vs. Bureau Veritas Re-Assays

The results of the ALS Chemex original assays versus the Bureau Veritas re-assays are shown in Table 12-4 and plotted in Figure 12-2. The results of the Bureau Veritas original assays versus the ALS Chemex re-assays are shown in Table 12-5 and plotted in Figure 12-3.

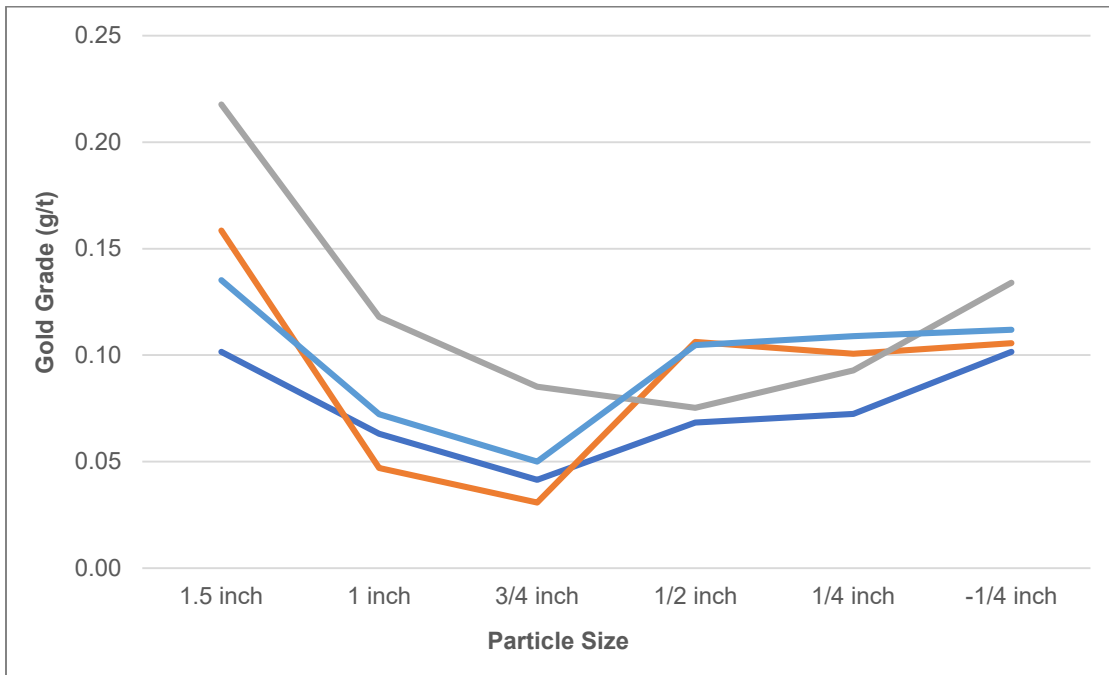
Figure 13-2: Bulk Sample Results— Particle Size vs. Residual Leaching

Following the completion of Phase 3 the entire pad was leached for an additional time then four bulk samples were taken to be analyzed for residual gold content. The samples were taken by trenching down approximately 1.5 m from surface. All samples were subject to size analysis, with individual size fractions analyzed for residual gold content. The d_{80} (80% passing) sizes for the samples ranged from approximately 1"–1.5" down to 5/8". The results for the analyses on the samples are illustrated in Figure 13-2. The average grades of the final residue samples were consistent, at approximately 0.10 g/t Au (± 0.05 g/t). The gold content by particle size was also relatively consistent for all sizes less than 1". A visible increase in residual gold was observed for rock sizes greater than 1".

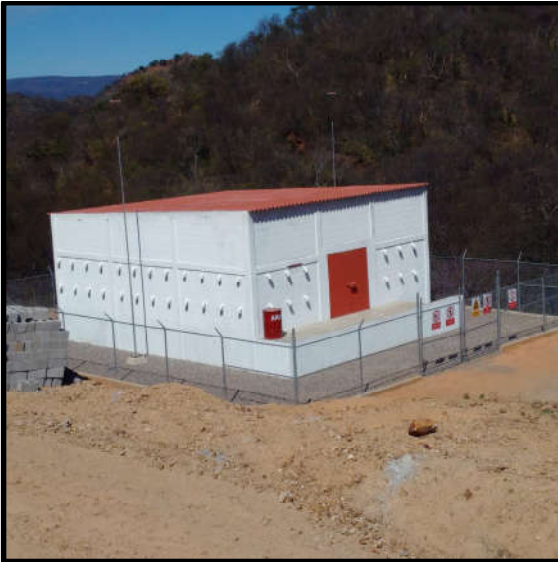
Figure 18-2: Explosives Magazine

Source: Minera Alamos Inc., July 15, 2021, looking north, photo taken at the Project.

- An explosives magazine (Figure 18-2).
- All earthworks related to the heap leach pad and carbon plant. The heap leach pad and barren and pregnant leach solution ponds have been constructed and are operational (further information can be found in Section 17) (Figure 18-3).

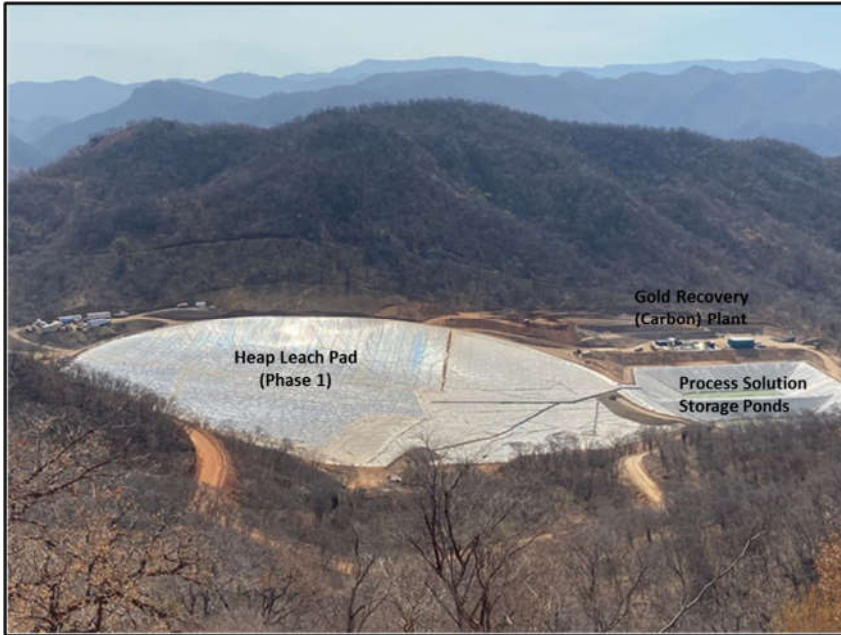
Figure 18-3: Heap Leach Pad and Process Storage Ponds

Source: Minera Alamos Inc., June 14, 2021, looking east, photo taken at the Project.

The pond, including the upper area allocated for the event pond, has been designed and constructed with impermeable plastic membranes (double-lined) installed above a clay under-liner. Leak detection-monitoring sumps are installed between the two plastic membranes.

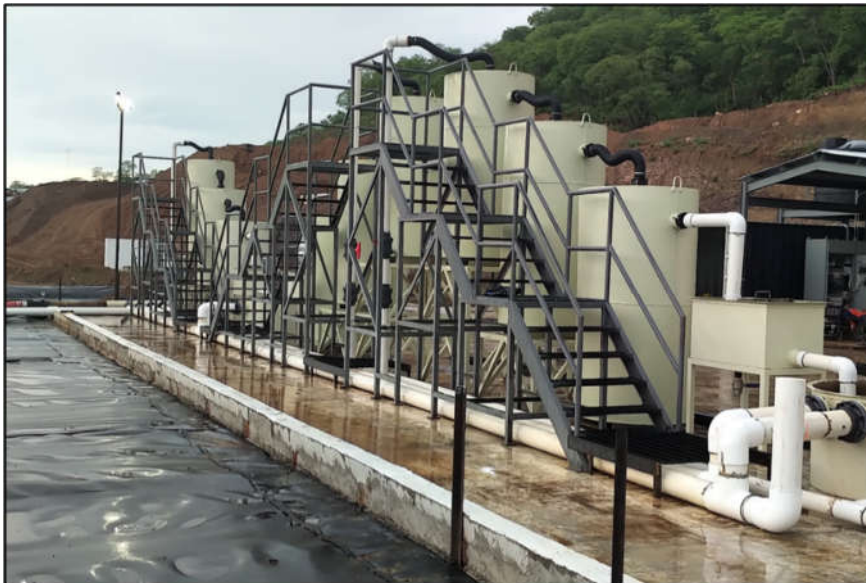
Figure 18-4: Gold Recovery (Carbon) Plant

Source: Minera Alamos Inc., July 17, 2021, Looking Northeast, photo taken at the Project.

- The carbon plant has been constructed; it includes containers for reagent storage; operation controls and process analysis; leach solution and preparation tanks; and carbon columns for gold recovery (see Section 17 for additional information) (Figure 18-4).
